Environmental Health Inspections  
East Mississippi Correctional Facility  
Meridian, Mississippi  
March 31, 2014 through April 3, 2014

June 13, 2014

Prepared by:  
**Diane Skipworth, R.D., L.D., R.S., CLLM**

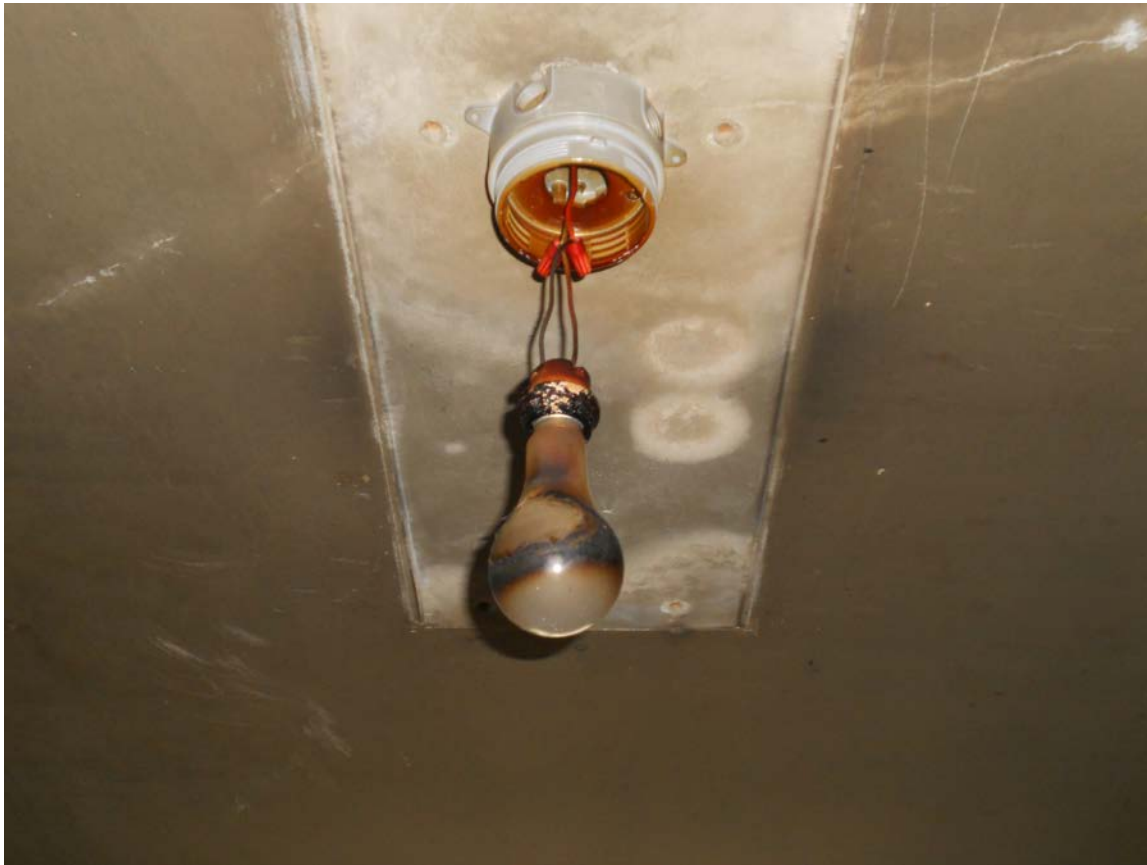
**Photo Exhibit: 1**

Housing Unit 6C: Ceiling light socket fixture with burned light bulb (DSCN0973) in Cell 206. The reported facility procedure for turning the cell light on and off in units 5 and 6 requires the inmate to screw and unscrew the light bulb. The light bulb in 6C-206 presents a serious hazard, as it is burned and dangling from exposed electrical wiring, subjecting the cell occupant to potential electrical shock, fire, broken glass, and falls from standing on the bunk or stool to access the light bulb. Additionally, prisoners reported that the exposed wires are used to light wicks which are used to ignite paper and laundry items, exposing prisoners and employees to the dangers associated with fires, including burns and smoke inhalation.

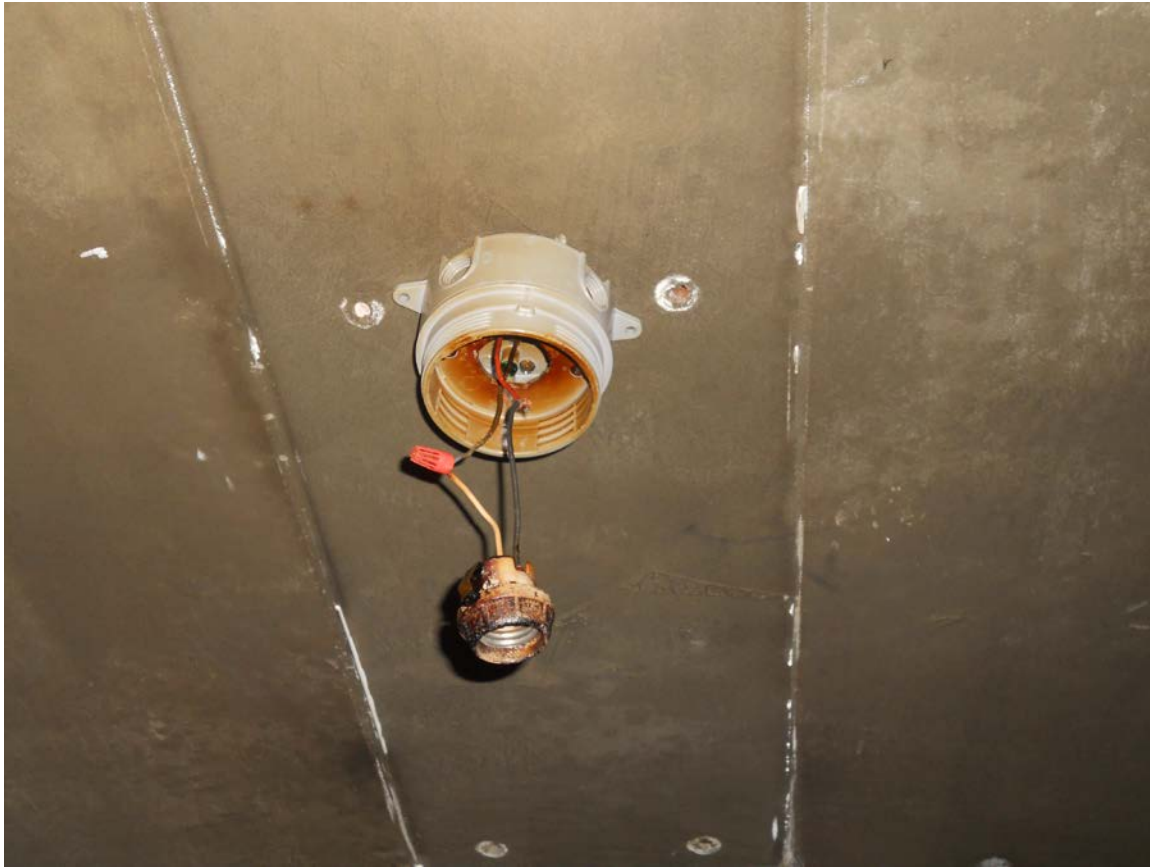
**Photo Exhibit: 2**

Housing Unit 6C: Ceiling light fixture and burned light socket (DSCN0978) in Cell 208. The light socket in 6C-208 presents a serious hazard, as it is burned and hanging on exposed electrical wiring, subjecting the cell occupant to potential electrical shock and fire. The condition of this fixture clearly indicates that the facility is not properly maintained, as required by the APHA standard.

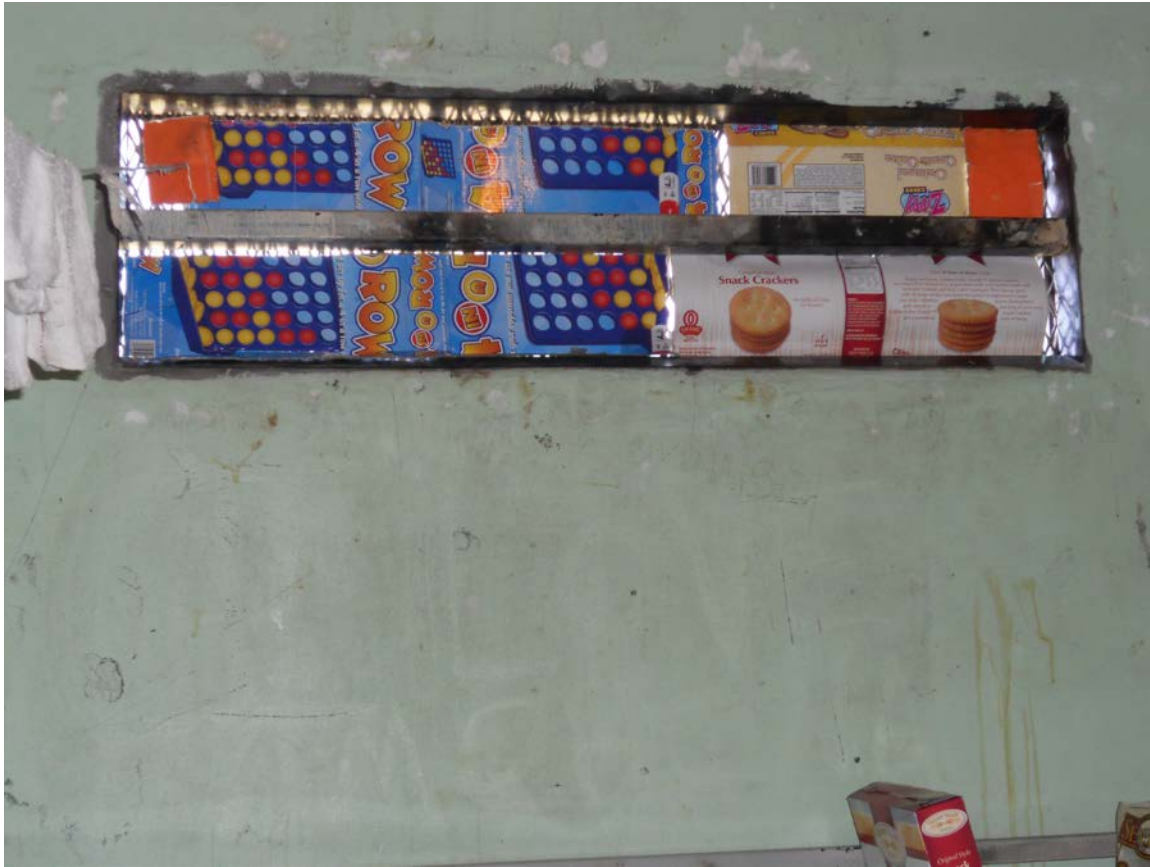
**Photo Exhibit: 3**

Housing Unit 5D: Window in Cell 103 (DSCN0697) covered with pieces of cardboard packaging, blocking the penetration of natural light. The illumination level in the cell was measured at 3.6 foot candles, far below the minimum 30 foot candles in living areas, as required by APHA standards. This condition creates an obstacle to personal hygiene, sanitation, safety, and security. I observed numerous covered cell windows throughout the facility. Additionally, the soil level on the wall supports the growth of disease-causing microorganisms and may attract disease vectors, including flies, cockroaches, and rodents.

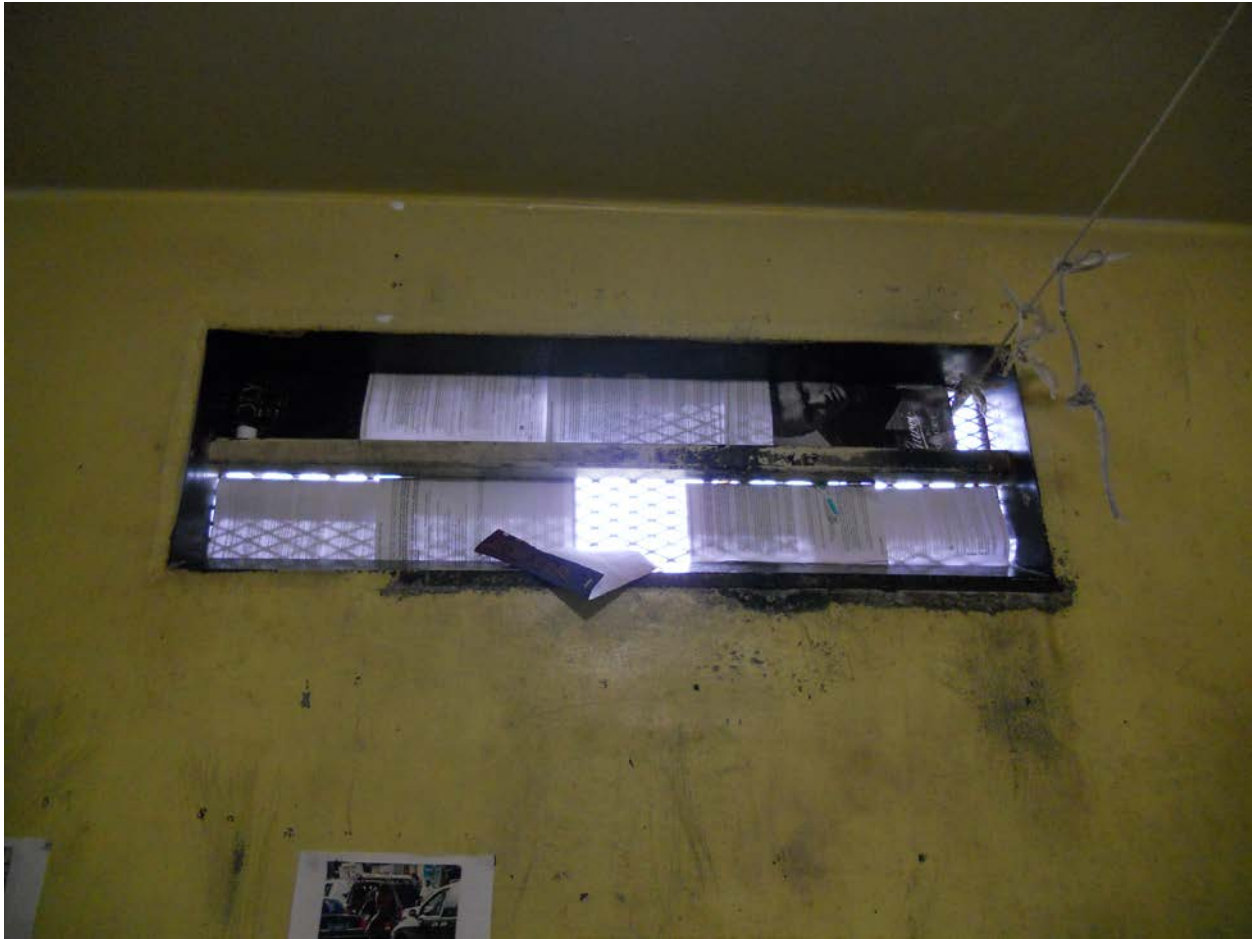
**Photo Exhibit: 4**

Housing Unit 5B: Window in Cell 104 (DSCN0847) covered with pieces of paper that block the penetration of natural light. Additionally, the soil level on the wall indicates a break-down in cleaning procedures and a lack of adequate cleaning for a lengthy period of time. Furthermore, a clothesline is attached to the window covering, indicative of the unsanitary practice of laundering linen and apparel items in the cell, rather than sending them to the laundry for proper washing and drying that eliminates disease-causing microorganisms and parasites.

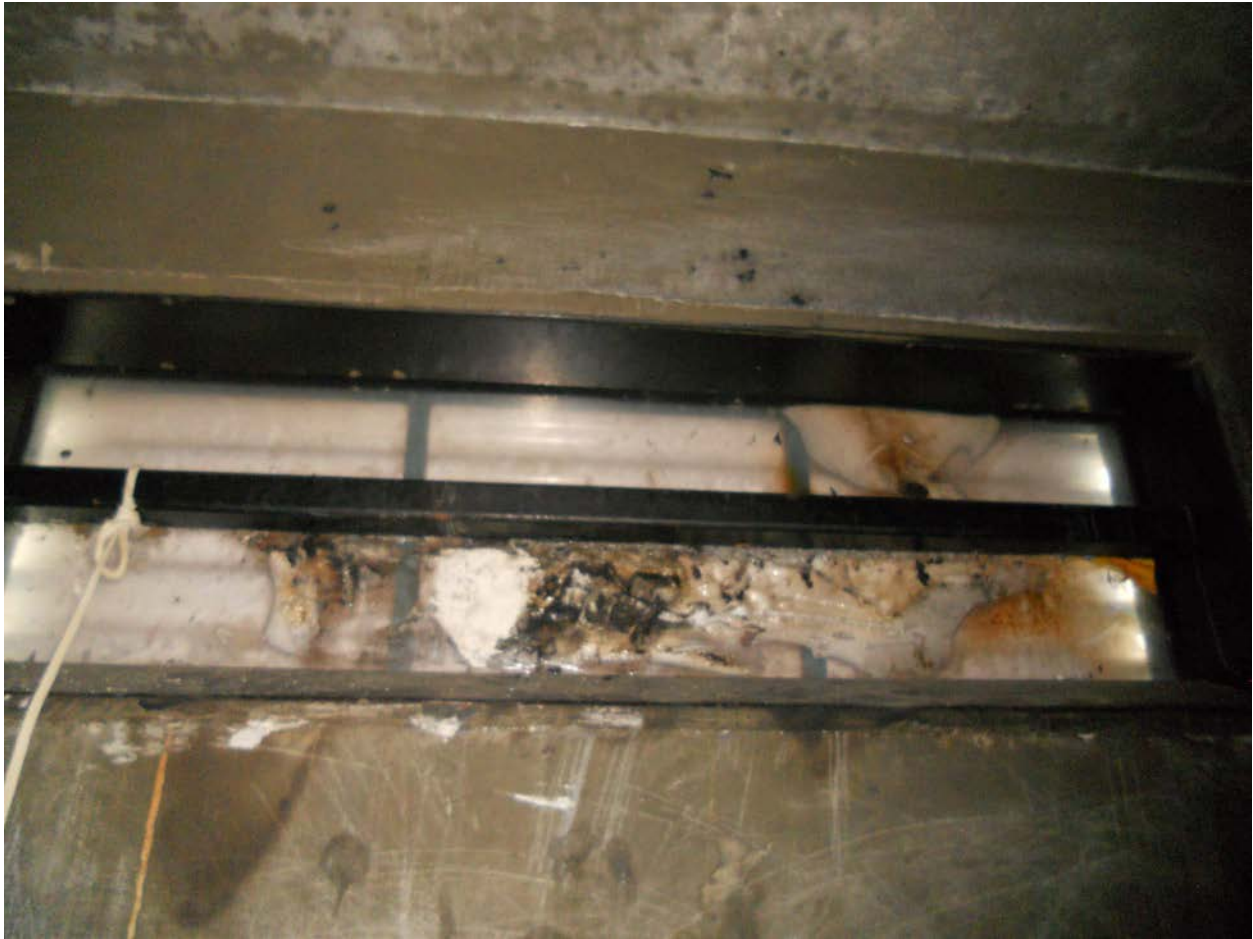
**Photo Exhibit: 5**

Housing Unit 6C: Burned window in Cell 214 (DSCN1032). The illumination level in the cell was measured at 1.2 foot candles, far below the minimum 30 foot candles in living areas, as required by APHA standards. The lighting deficiency creates an environment that is not conducive to personal hygiene, sanitation, safety, or security. Additionally, the unfinished wall and ceiling surface was uneven and hard to clean effectively and the overall condition of this cell was extremely dim, dirty, and dingy. Furthermore, the dark unfinished walls do not reflect light, adding to the problem of insufficient illumination that inhibits cleaning, increases the likelihood of accidental injury, and creates safety and security concerns in a correctional environment. The burned window is evidence of a fire incident. Additionally, a clothesline is tied to the window frame.

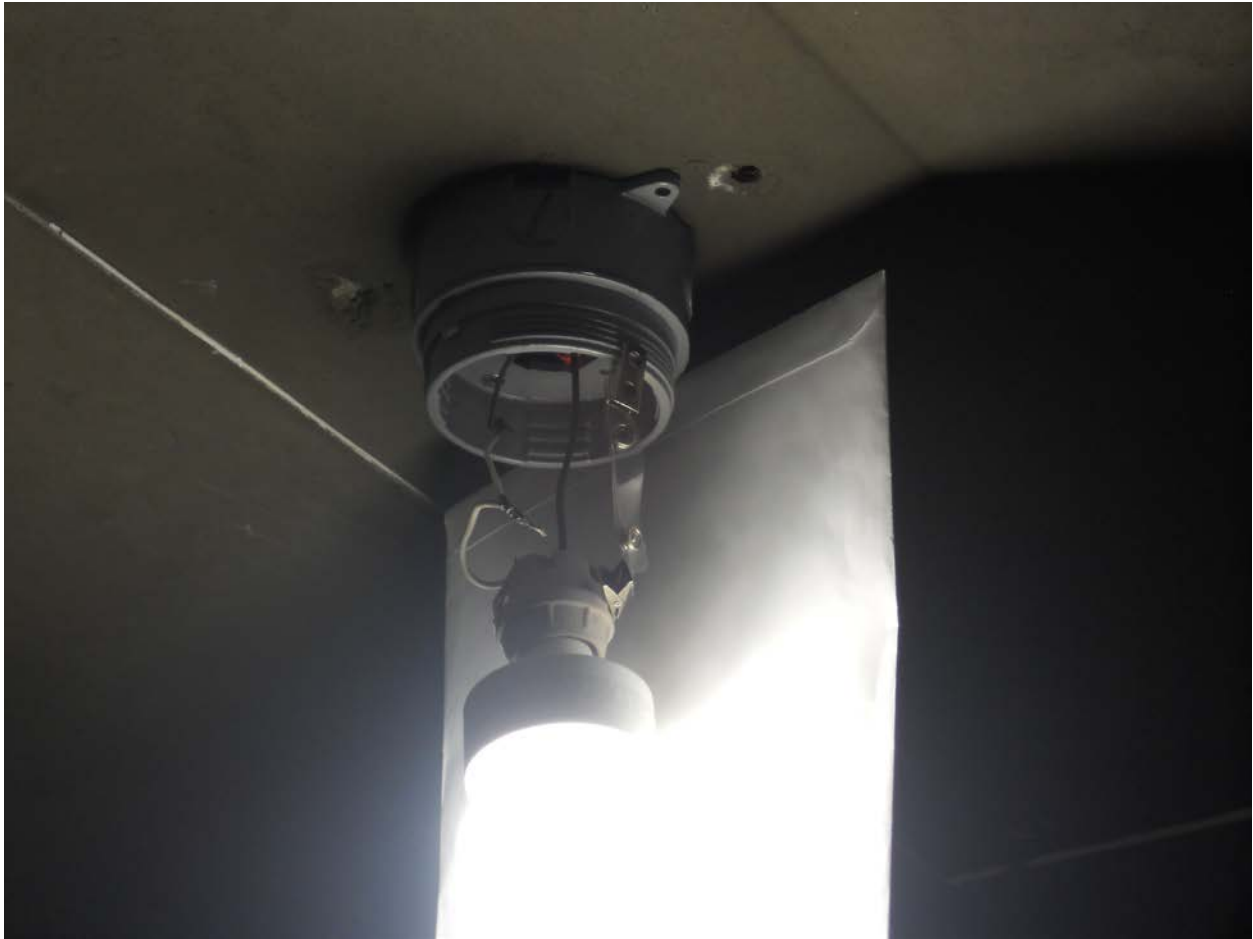
**Photo Exhibit: 6**

Housing Unit 6B: Improvised light shade (DSCN1211) in Cell 107. The paper envelope resting on the bare light bulb poses a serious fire hazard, as do the exposed electrical wires.

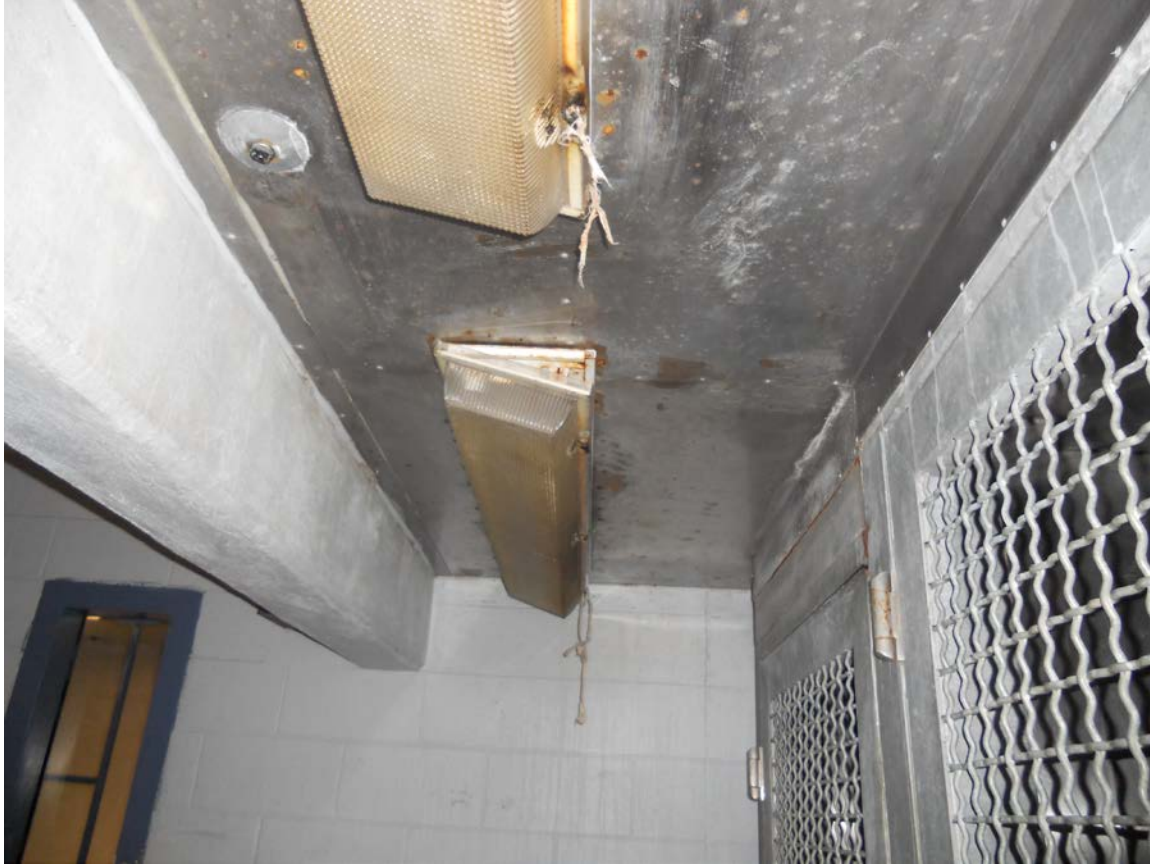
**Photo Exhibit: 7**

Housing Unit 6A: Lower shower area (DSCN1113) ceiling light fixtures. The light fixtures do not provide adequate illumination. The lighting level in this area measured at 0.49 to 1.1 foot candles, far below the minimum required level of 20 foot candles. Thus, the light levels are not conducive to personal hygiene, sanitation, safety, or security. Furthermore, the dangling light covers that appear to be held in place with string also pose a safety hazard.

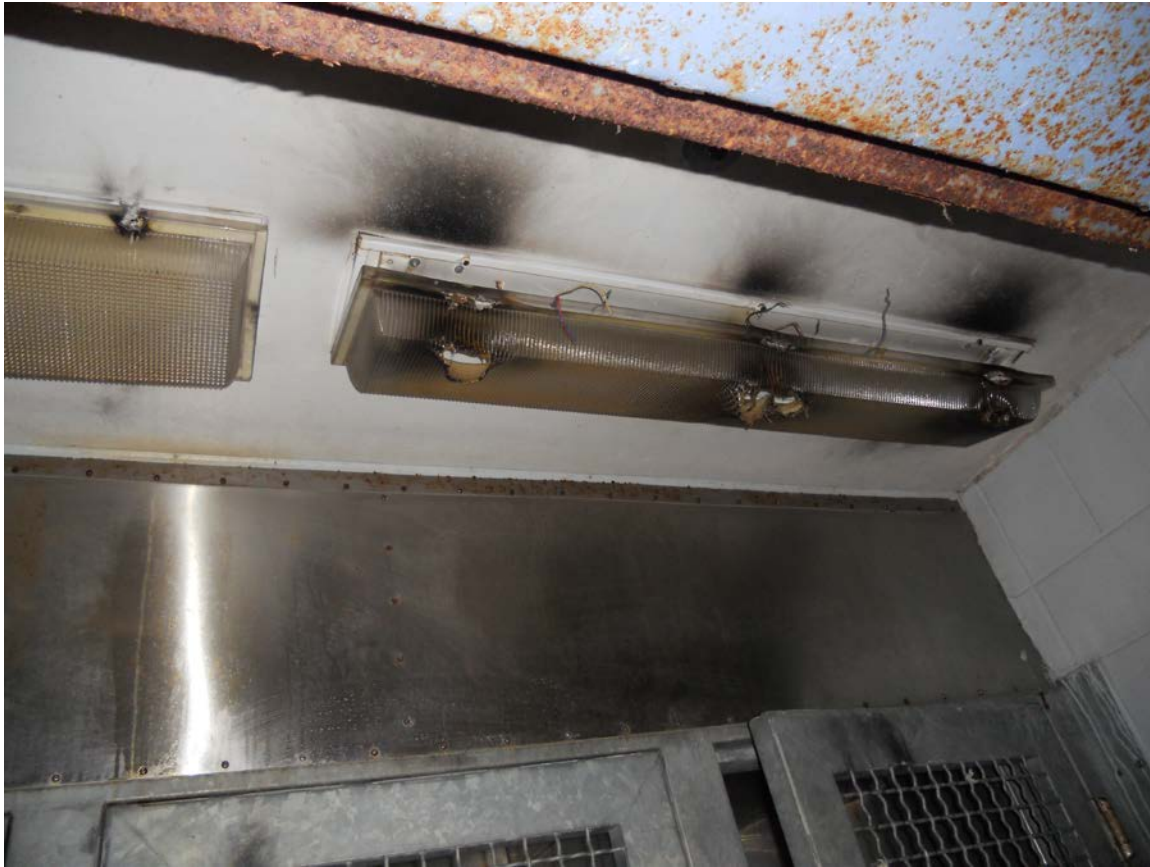
**Photo Exhibit: 8**

Housing Unit 6A: Upper shower area (DSCN1124) ceiling light fixtures. The light fixtures do not provide adequate illumination; the lighting level in this area measured 0.7 to 1.5 foot candles, far below the minimum required level of 20 foot candles. Thus, the light levels are not conducive to personal hygiene, sanitation, safety, or security. Furthermore, the exposed wires were live, creating a serious hazard, especially in a wet shower area. The scorched areas on the ceiling indicate previous spark or fire incidents. Additionally, the rusty condition of the metal ceiling prevents easy, effective cleaning thereby promoting the growth of disease-causing microorganisms. The presence of rust and the condition of the light fixtures clearly indicate that the facility is not properly maintained in the manner required by the APHA standard requiring prisons be kept in good repair.

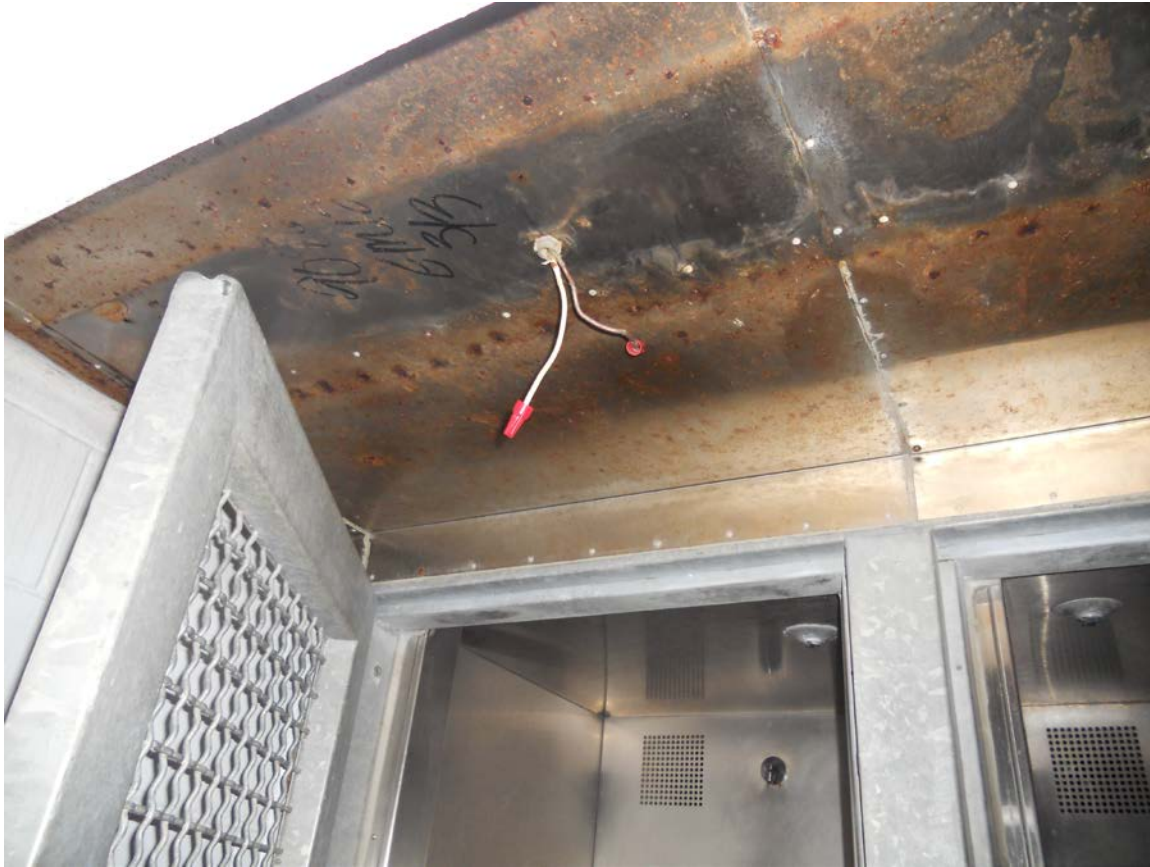
**Photo Exhibit: 9**

Housing Unit 6B: Lower shower area (DSCN1192) ceiling light fixtures. The exposed wires are in the location of the intended placement of the light fixture that is supposed to illuminate the entire shower area, as the shower stalls do not contain light fixtures. The light fixtures do not provide adequate illumination; the lighting level in this area measured 0.4 to 1.3 foot candles, far below the minimum required level of 20 foot candles. Thus, the light levels are not conducive to personal hygiene, sanitation, safety, or security. Furthermore, the exposed wires were live, as measured by an AC voltage detector, creating a shock or electrocution hazard, especially in a wet shower area. The rusty ceiling is not conducive to the effective cleaning and disinfection required to eradicate disease-causing microorganisms in a shower area.

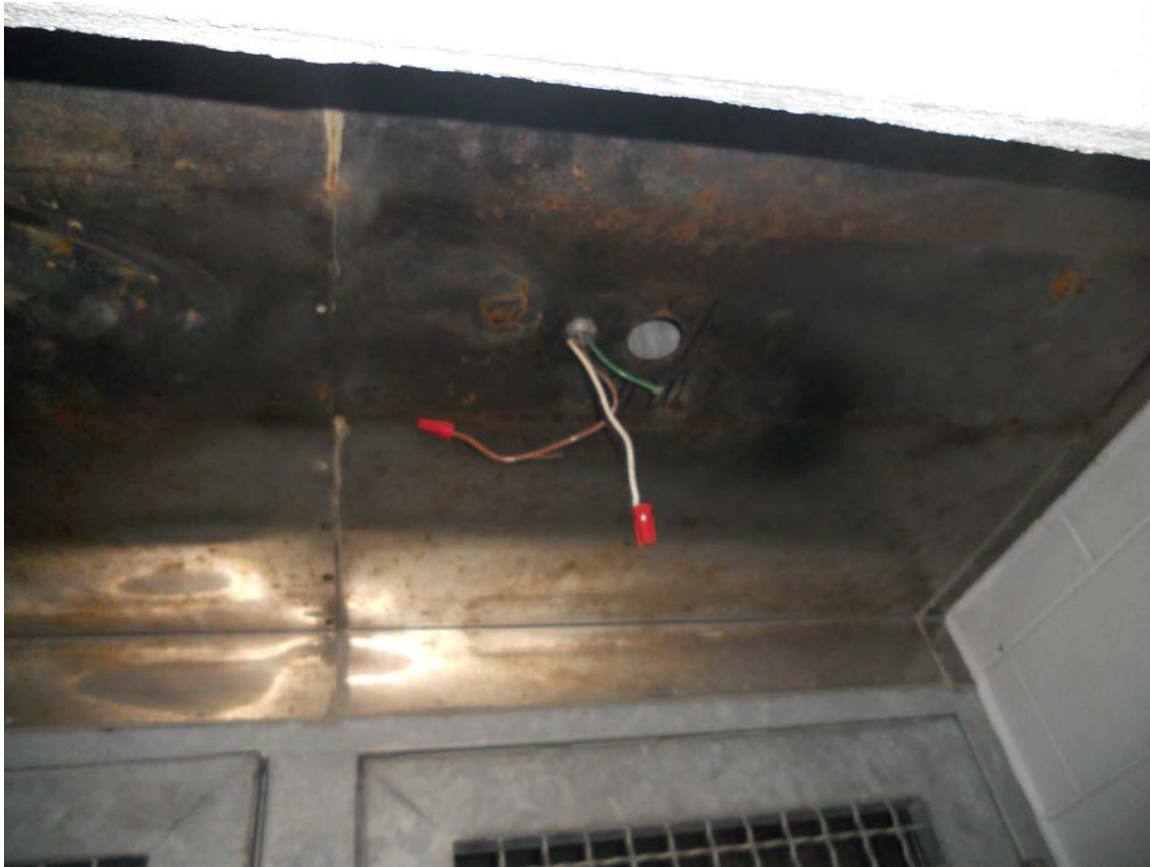
**Photo Exhibit: 10**

Housing Unit 6C: Lower shower area (DSCN0879) ceiling outside the shower stalls. The exposed wires are in the area designed for the light fixture for the entire shower area; the individual shower stalls do not contain light fixtures. The lighting level in this area measured 0.09 to 0.6 foot candles, far below the minimum required level of 20 foot candles. Thus, the light levels are not conducive to personal hygiene, sanitation, safety, or security.

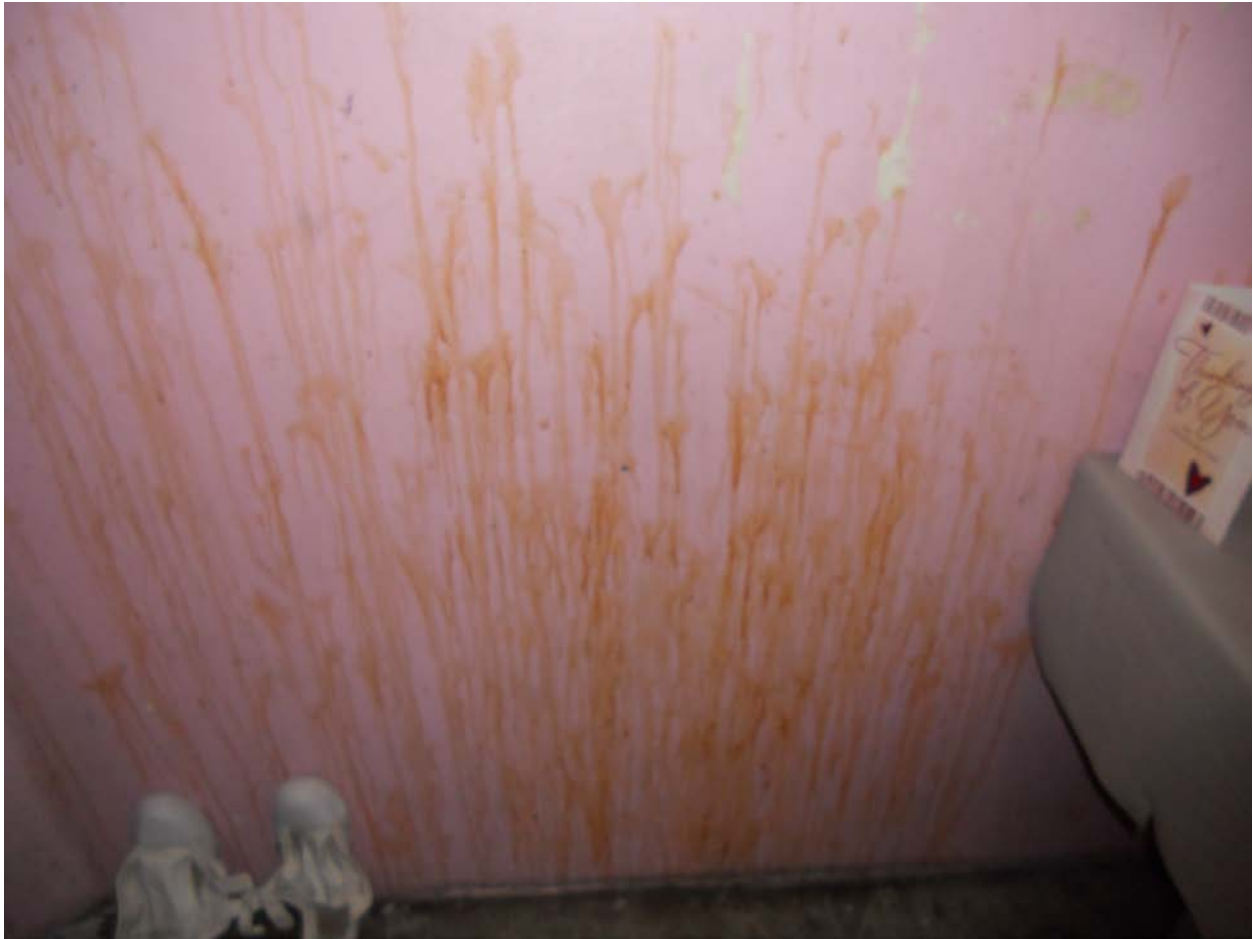
**Photo Exhibit: 11**

Housing Unit 5A: Wall in cell 114(DSCN0736). The entire cell was extremely filthy and the general level of sanitation found throughout housing unit 5 was unsanitary. The soil accumulation on this wall not only supports the growth of disease-causing microorganisms, but may also attract disease vectors, including flies, cockroaches, and rodents.

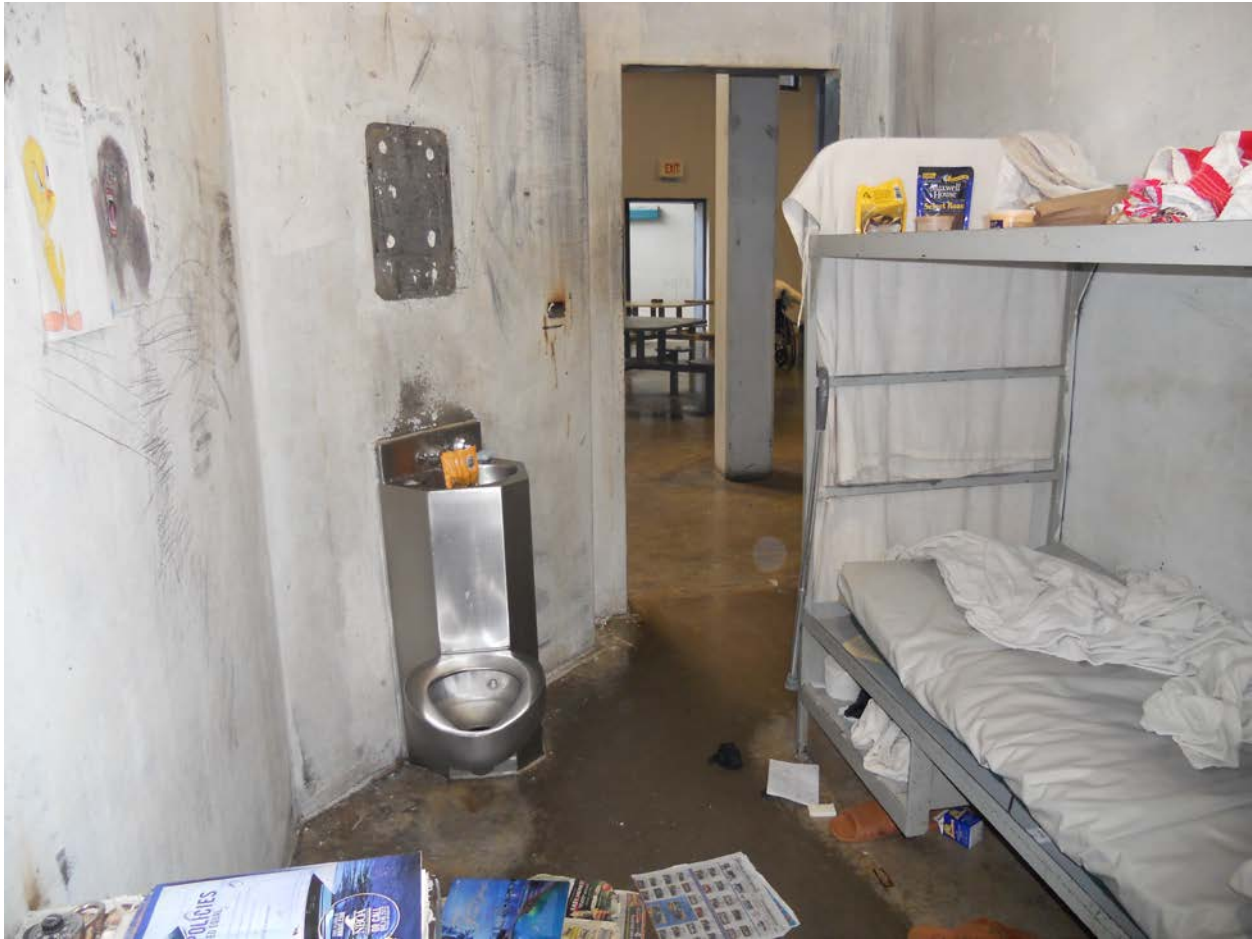
**Photo Exhibit: 12**

Housing Unit 6A: Cell 109 (DSCN1159). A prisoner in a wheelchair occupied cell 109, although it does not meet the guidelines specified in the ADA's Accessible Cells in Correctional Facilities Design Guide. Additionally, this cell is representative of the general conditions in most of the living areas. Food trash, such as the milk carton under the bed, support the growth of disease-causing microorganisms, and attract disease vectors, including flies, cockroaches, and rodents. Furthermore, most of the cells had accumulations of trash and debris, such as the newspapers on the floor pictured here. This build-up of trash and debris not only constitutes a fire hazard, but also provides harborage for disease vectors. Furthermore, the walls and floors show accumulated dirt, dust, and debris, and they are in need of cleaning and renovation. Failure to properly perform cleaning functions ultimately leads to the break-down in sanitation observed in this cell and throughout the EMCF housing units.

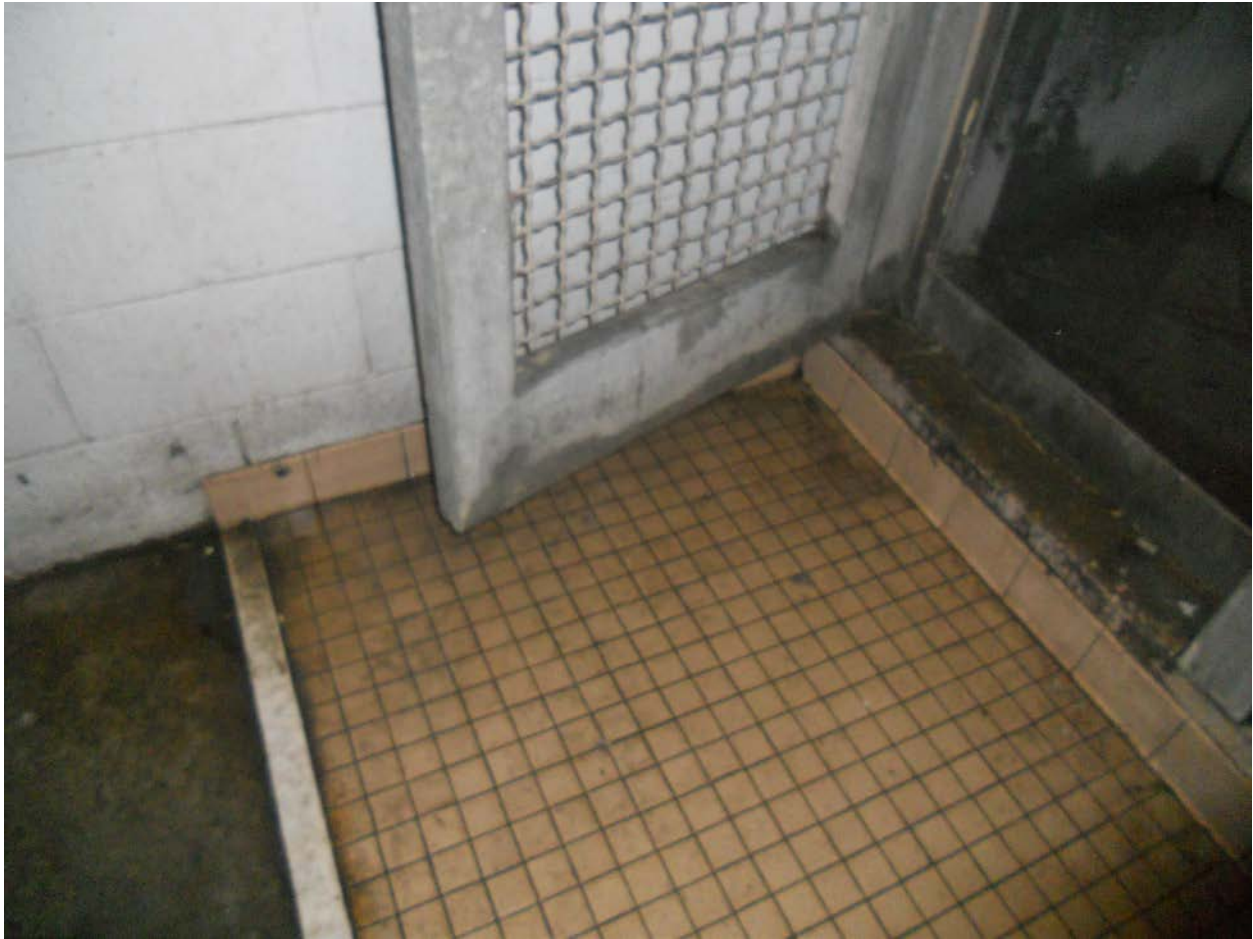
**Photo Exhibit: 13**

Housing Unit 6C: Unit 6C Upper Shower area floor (DSCN1054). The tile floor and adjacent wall are dirty with an accumulation of soil. The threshold at the base of the shower door is not a smooth surface and is therefore not easily cleanable. The condition of this shower floor is unsanitary and promotes the growth of potential disease causing microorganisms.

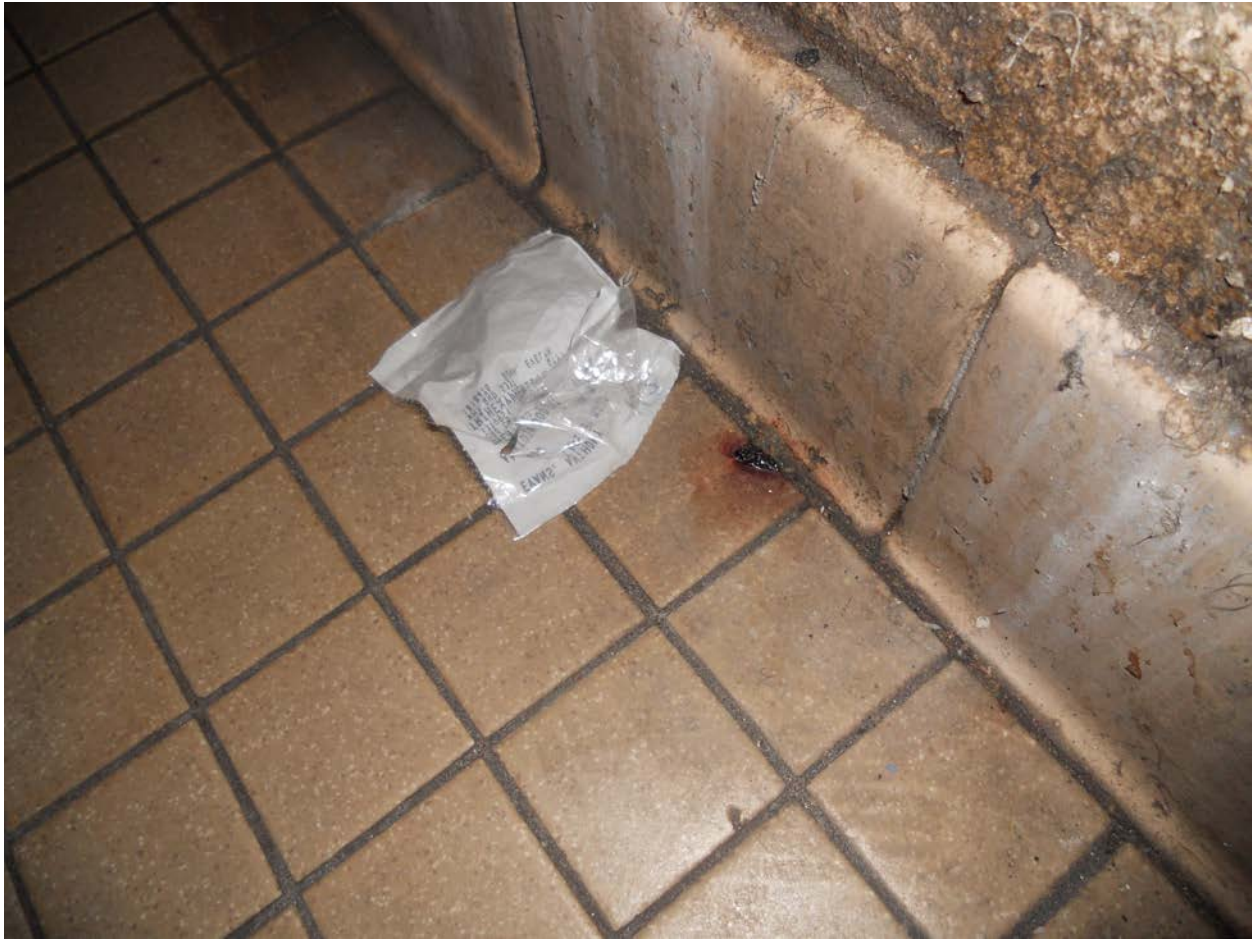
**Photo Exhibit: 14**

Housing Unit 6C: Unit 6C Lower Shower area floor (DSCN0890). The tile floor is dirty with an accumulation of soil. The threshold at the base of the shower door is not a smooth surface and is therefore not easily cleanable, seen in the right upper hand corner of the photo. The condition of this shower floor is unsanitary, promoting the growth of disease-causing microorganisms and mold. Additionally, the unidentified red matter, to the right of the medication package appears to be dried blood and poses a potential blood-borne pathogen hazard as prisoners often exit the shower barefooted or place their towels, clothing, and personal items outside the door while showering. Prisoners can accidentally come in contact with what appears to be blood, especially in this dimly lit area measuring only 0.09 to 0.6 foot candles of light. The APHA minimum lighting intensity standard for washrooms is 20 foot candles.

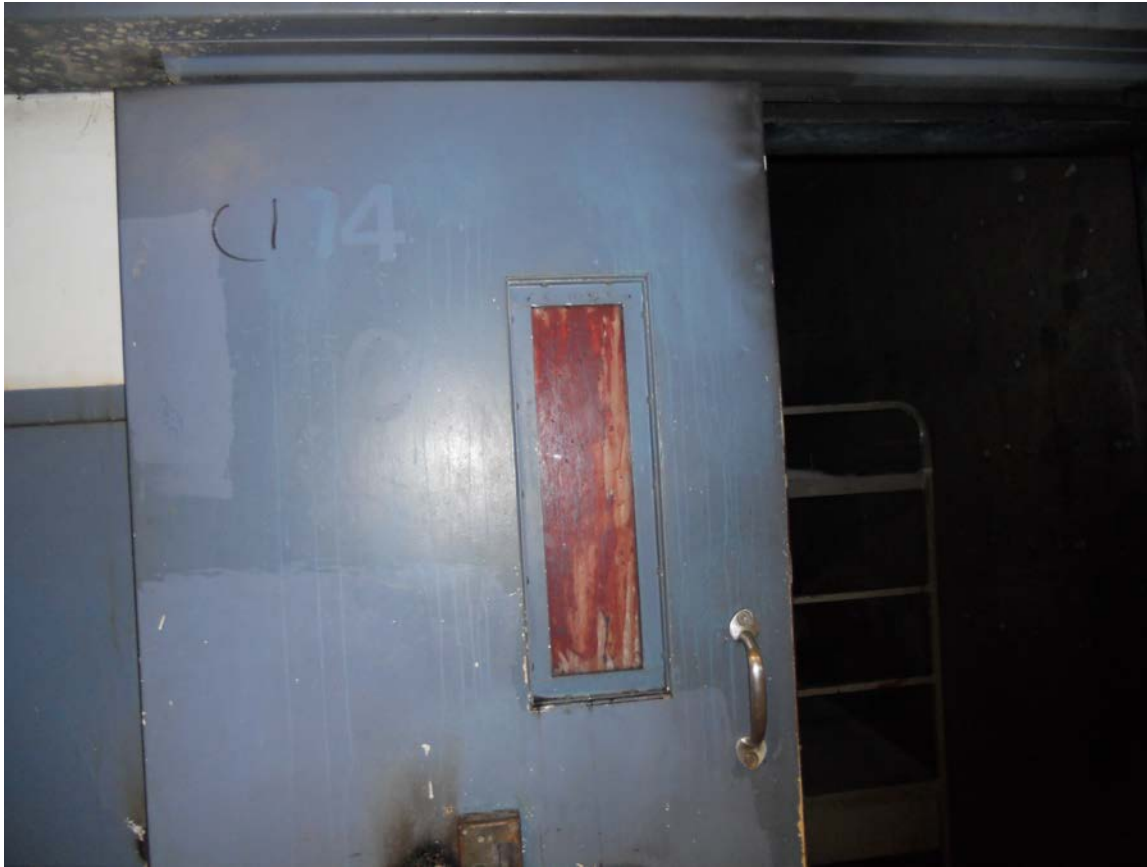
**Photo Exhibit: 15**

Housing Unit 6C: Blood on the window of cell door C114 (DSCN0918). This photo was taken from the dayroom facing the cell door. This cell had a substantial amount of blood on the floor at approximately 11:30 a.m., on Wednesday, April 2, 2014. The cell was unoccupied at the time these pictures were taken. Upon asking how long the blood had been present, the escorting supervisory officer responded that it had probably happened on Monday. An inmate in the unit, who asked to remain anonymous, reported that the prisoner occupying the cell had intentionally cut himself on Saturday and then again on Sunday, and that the cell had been in the current condition since the inmate was removed for medical care. Therefore, blood had been visible on the window for at least several days. The mere fact that this condition was allowed to remain for an extended period of time clearly indicates that EMCF is not adhering to universal precautions for handling blood and other potentially infectious materials as required by the APHA, OSHA, and all other recognized standards, thereby exposing prisoners and staff to blood-borne pathogens, including hepatitis B virus and HIV.

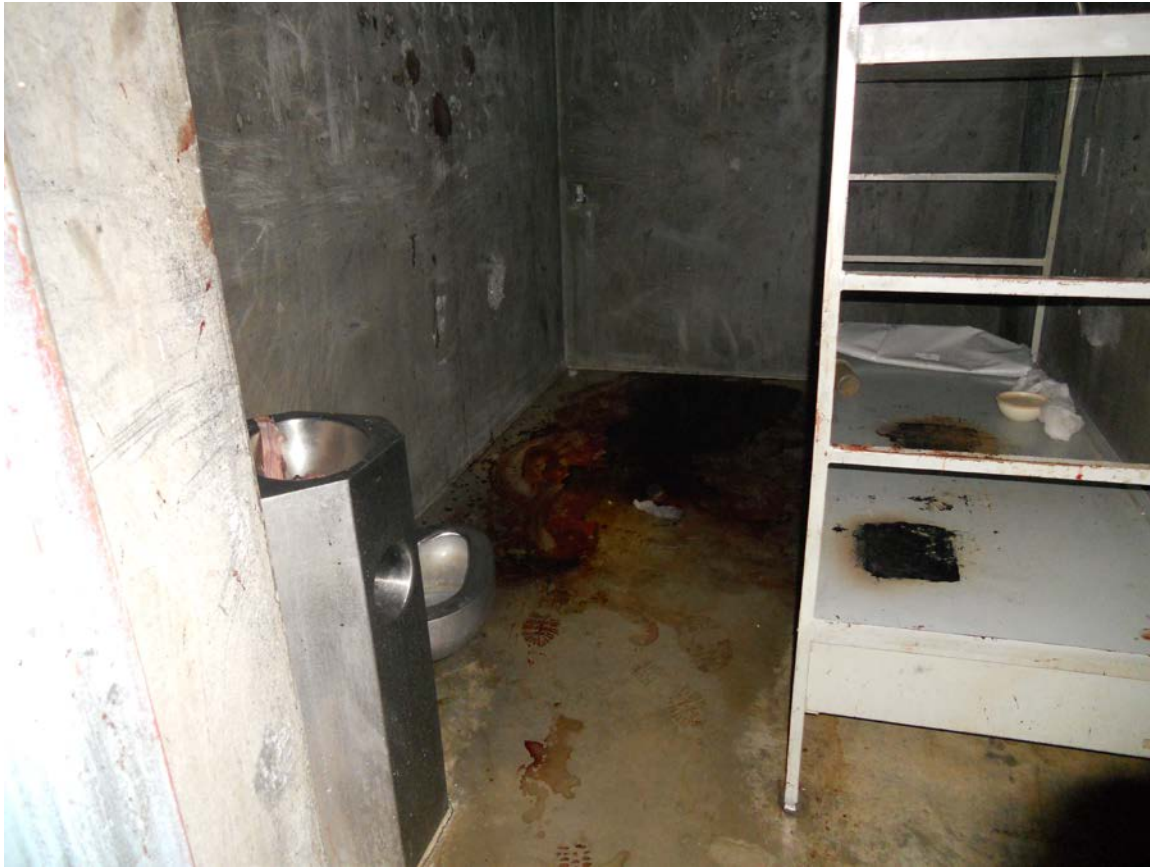
**Photo Exhibit: 16**

This photo also illustrates the general dark, dingy condition of the cells at EMCF. Furthermore, the seat and desk are missing from the cell. Therefore, the occupant will have no place to sit except for the bunk, making routine activities such as consuming meals and writing difficult.

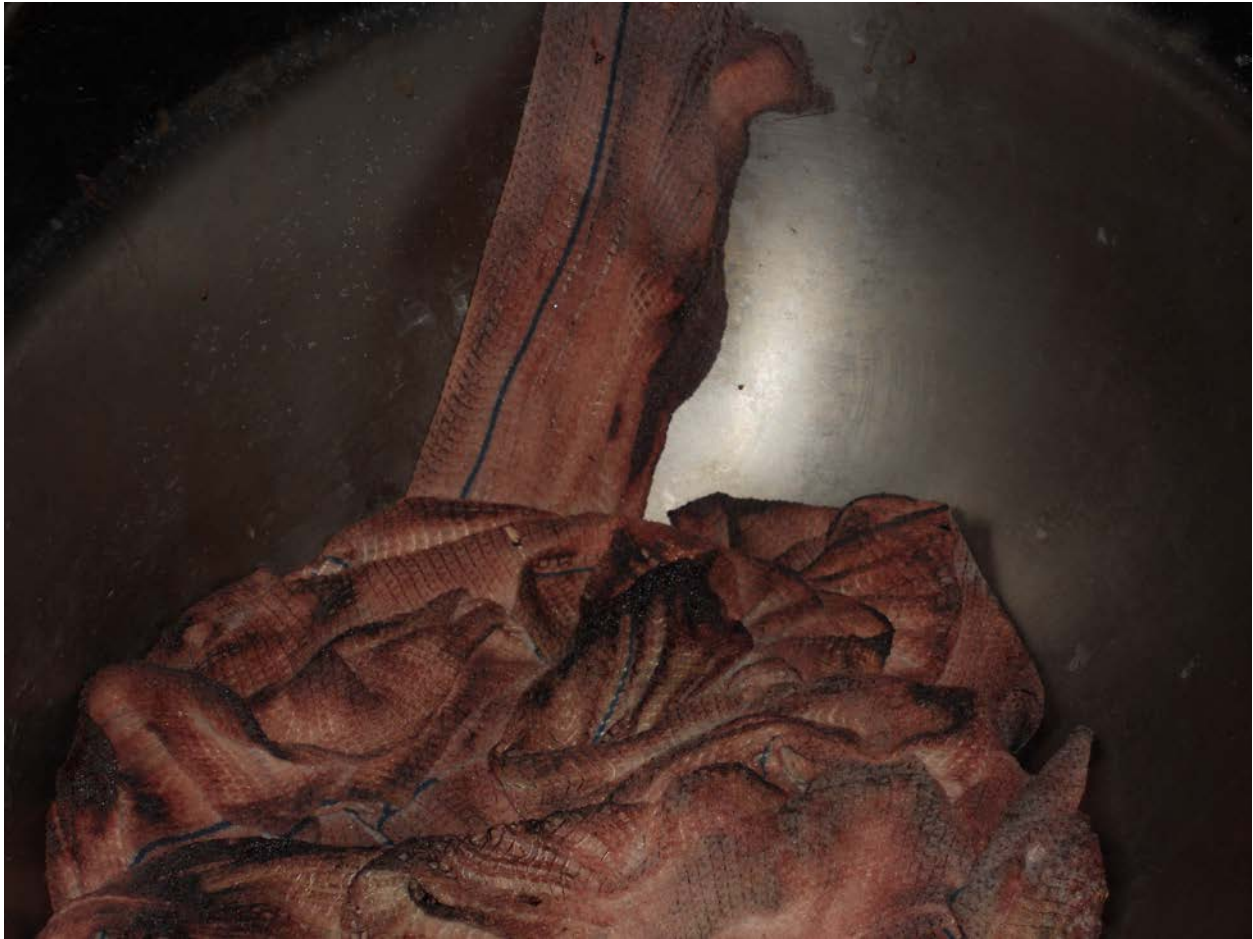
**Photo Exhibit: 17**

Housing Unit 6C: Detailed photo of bloody material in the sink of cell C114 (DSCN0923). Please refer to Photo Exhibits 15, 16, and 18 for additional information.

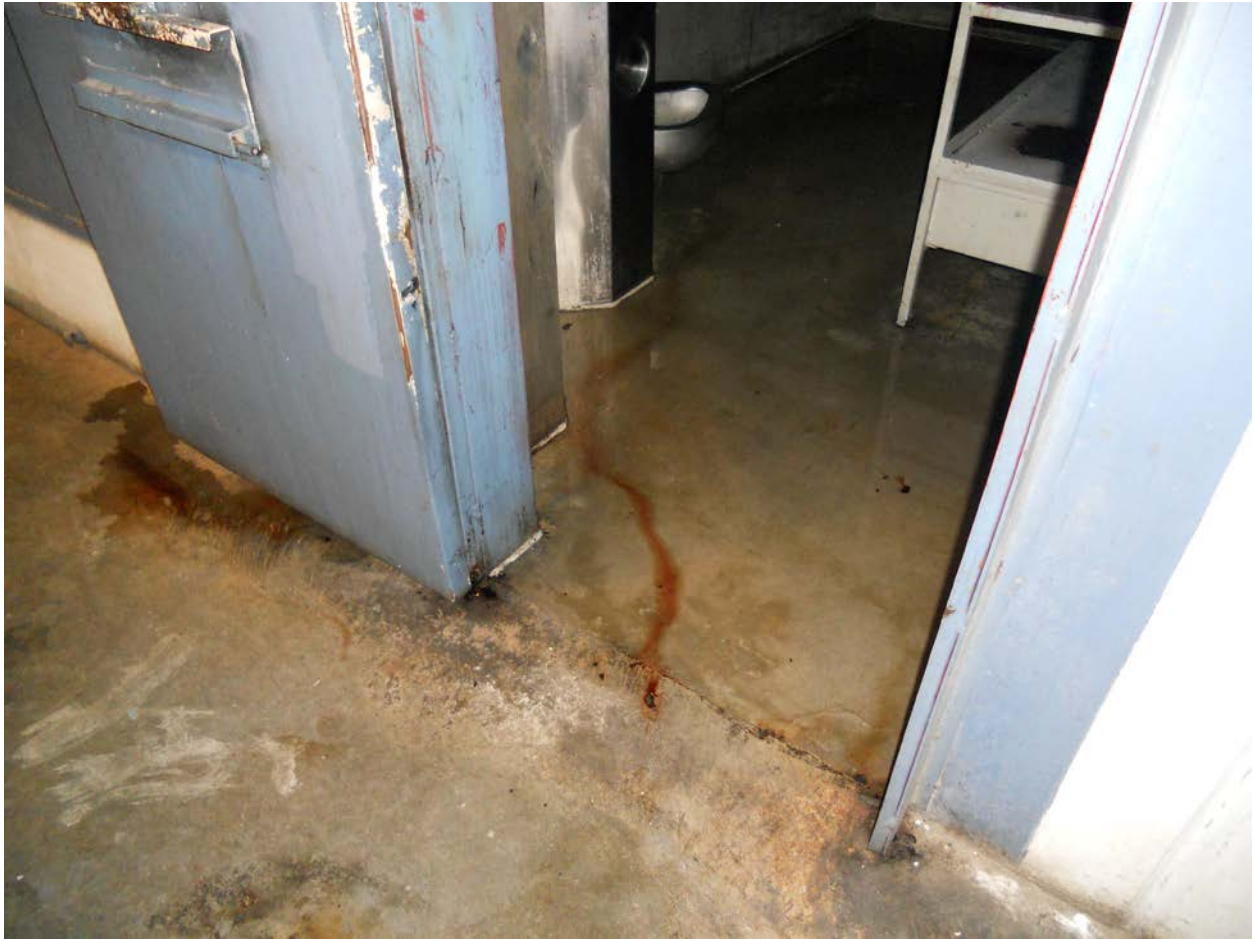
**Photo Exhibit: 18**

Housing Unit 6C: Blood on the floor of cell C114 (DSCN0944). This picture was taken approximately two hours after the blood in the cell was initially found and after the area was “cleaned.” Staff apparently considered the clean-up complete, as evidenced by the absence of any activity in the cell, including cleaning tasks or the presence of supplies, workers, barricades, or posted notification not to enter or occupy the cell. However, a trail of bloody water was still flowing out of the cell along with pieces of what appear to be dried blood, potentially exposing those in the vicinity to blood-borne pathogens, including hepatitis B virus and HIV.
