Environmental Health Inspections  
East Mississippi Correctional Facility  
Meridian, Mississippi  
March 31, 2014 through April 3, 2014

June 13, 2014

Prepared by:  
**Diane Skipworth, R.D., L.D., R.S., CLLM**

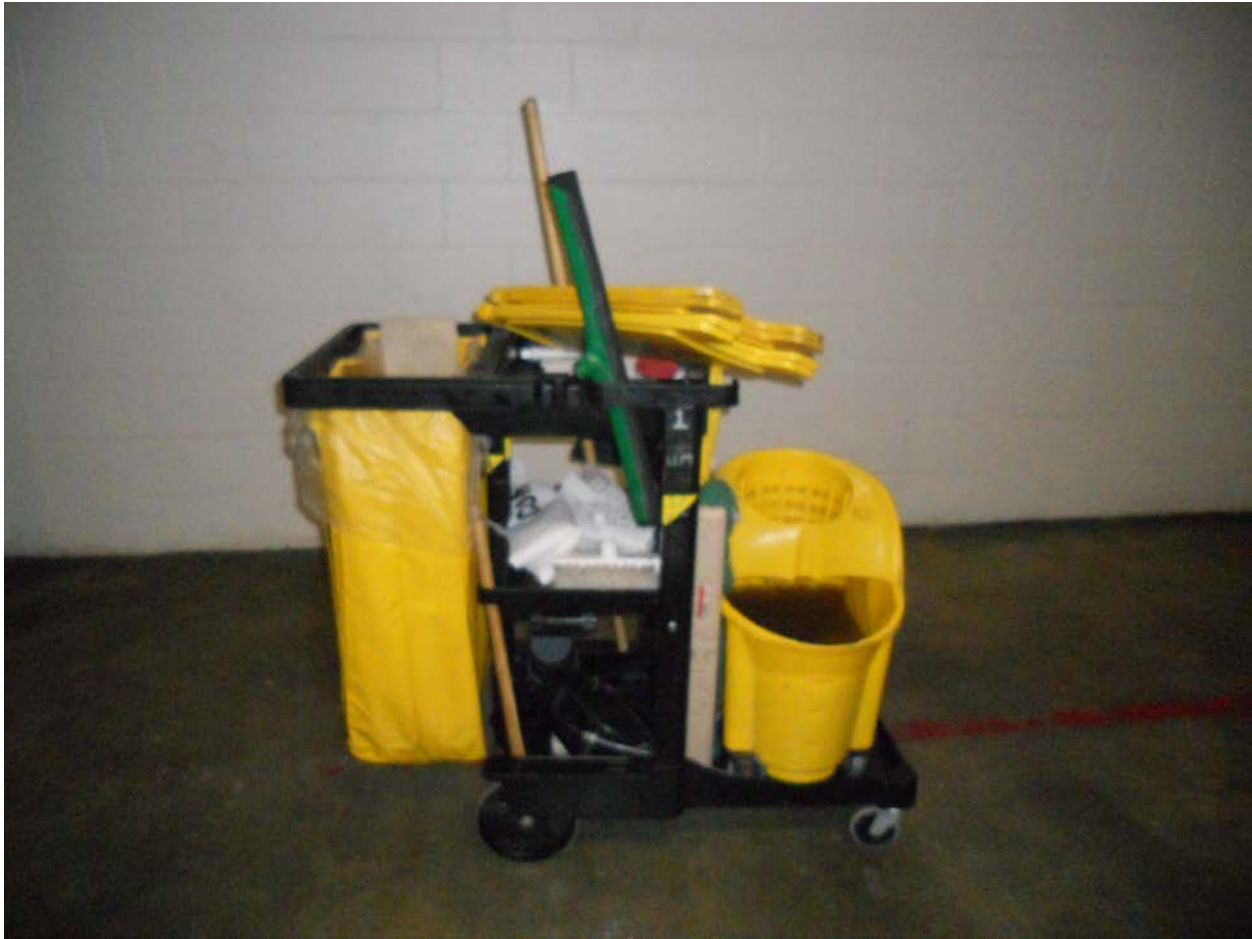
**Photo Exhibit: 19**

Housing Unit 6D: Cleaning cart (DSCN1100) on Unit 6D at approximately 10:00 a.m., on April 3, 2014. An inmate worker was using the supplies on the cart to sweep and mop the dayroom. However, there were no bottles of cleaning chemicals on the cart, including disinfectants necessary to eliminate potential disease-causing microorganisms.

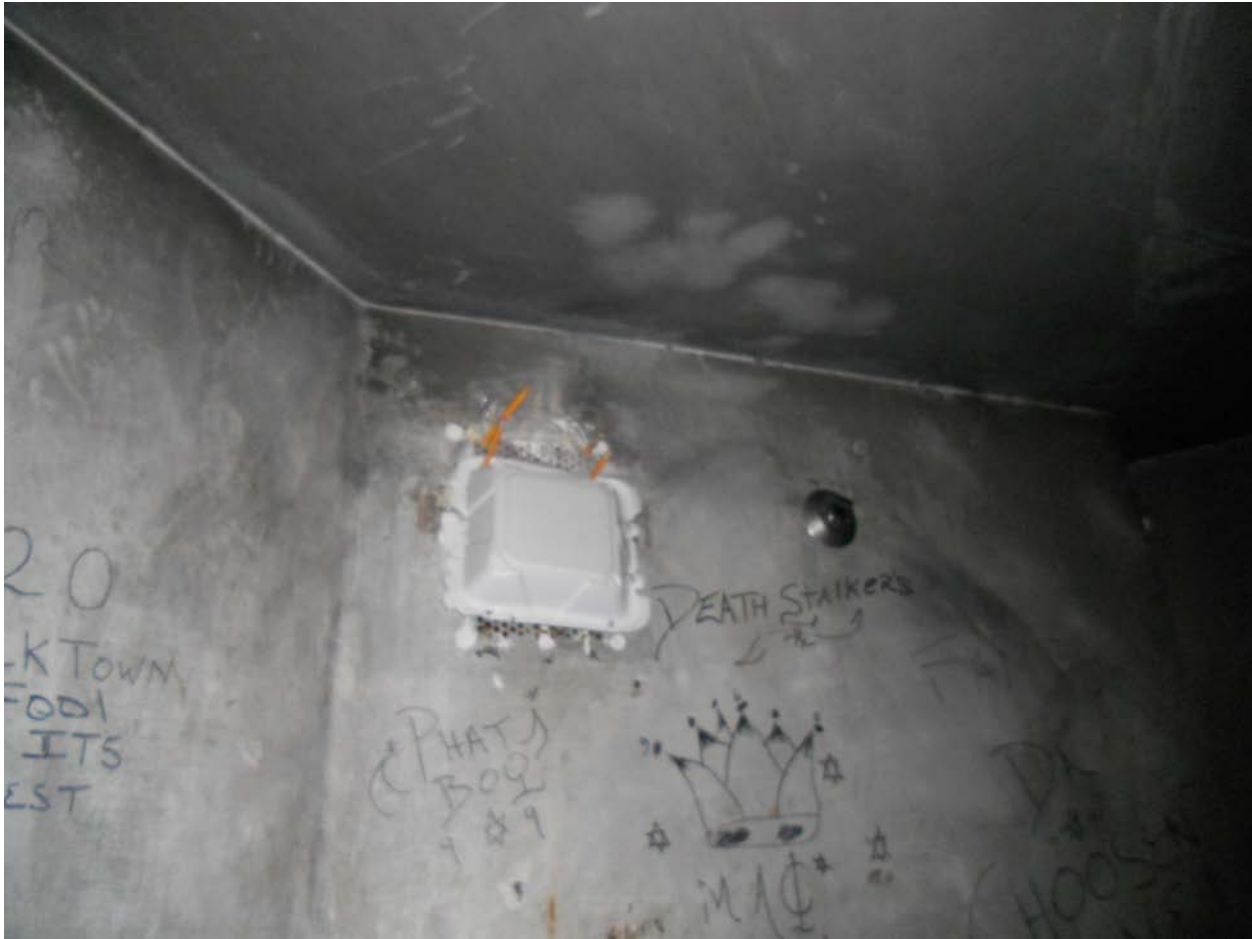
**Photo Exhibit: 20**

Housing Unit 6D: Ventilation grille in Cell 101 (DSCN1085) blocked by a Styrofoam food container. The white substance underneath appears to be toothpaste residue that was previously used to “glue” blocking materials over the vent. The toothpaste residue poses an additional hazard as it attracts insects, specifically roaches that carry disease-causing microorganisms. The covered vent restricts the airflow and exchange necessary for a healthy and comfortable environment. Additionally, the unfinished wall surface is not smooth and easily cleanable and the permeable nature of the unfinished walls and ceilings impedes proper cleaning and disinfection. Furthermore, the gray bare walls do not reflect light, adding to the problem of insufficient illumination that inhibits cleaning, increases the likelihood of accidental injury, and creates safety and security concerns.

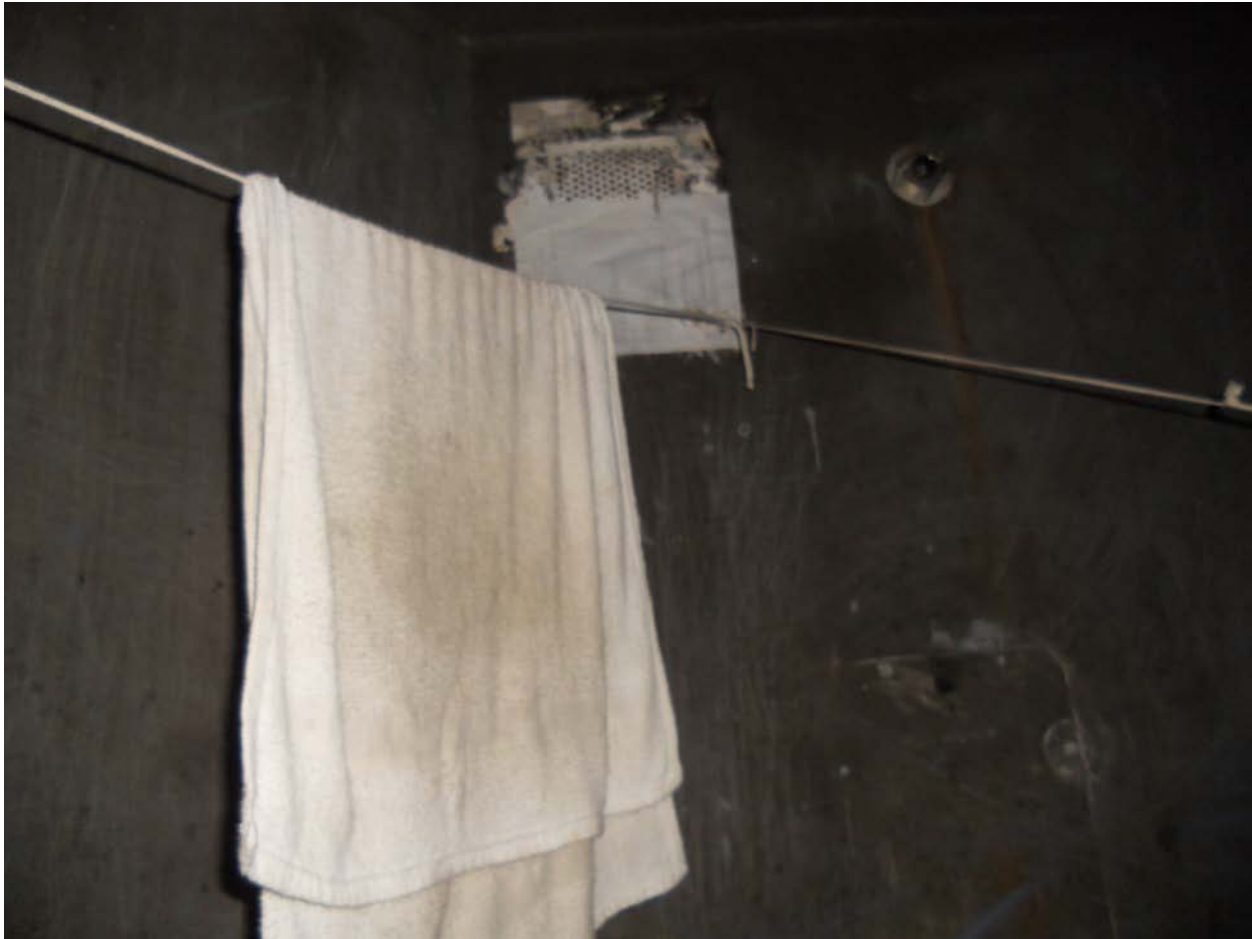
**Photo Exhibit: 21**

Housing Unit 6C: Ventilation grille in Cell 105 (DSCN0963) blocked by paper that appears to be “glued” over the vent with toothpaste. The toothpaste poses a hazard as it attracts pests, specifically roaches that carry disease-causing organisms. The covered vent restricts the airflow and exchange necessary for a healthy and comfortable environment. Additionally, the unfinished wall surface is not smooth and easily cleanable. The permeable nature of the unfinished walls and ceilings impedes proper cleaning and disinfection; the overall condition of this cell was extremely dirty and dingy. Furthermore, the unfinished walls do not reflect light, adding to the problem of insufficient illumination that hinders cleaning, increases the likelihood of accidental injury, and creates safety and security concerns in a correctional environment.

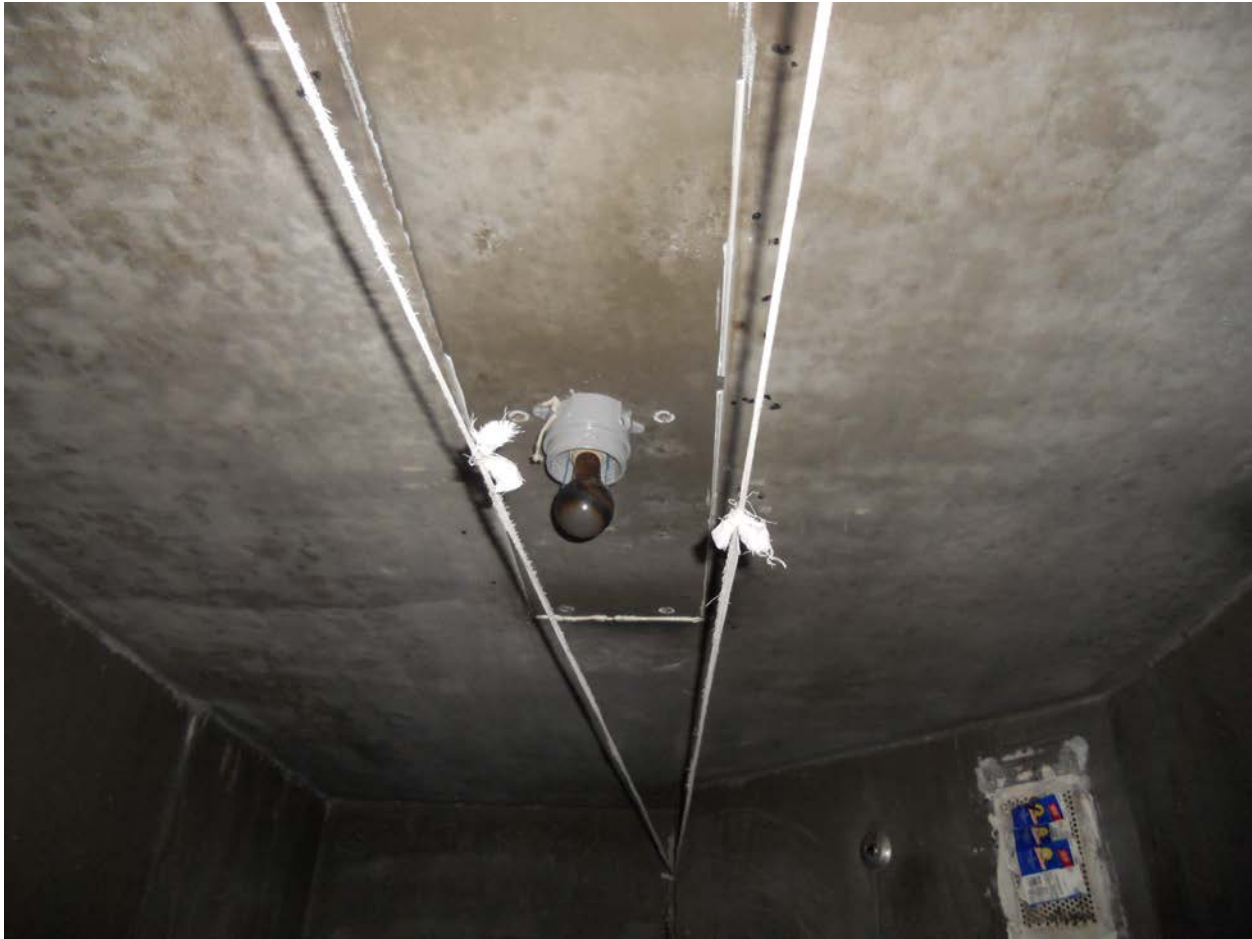
**Photo Exhibit: 22**

Housing Unit 6C: Ventilation grille in Cell 212 (DSCN1014) blocked by milk cartons, burned light bulb, and clotheslines. The covered vent restricts the airflow and exchange necessary for a healthy and comfortable environment. Additionally, the unfinished wall surface is not smooth and easily cleanable. The unfinished ceiling and wall surfaces do not adequately reflect light, adding to the problem of insufficient illumination. Furthermore, the burned light bulb is a safety hazard, and the “clotheslines” running parallel to the exposed bulb create a fire hazard. Rodent droppings were also found in this cell.

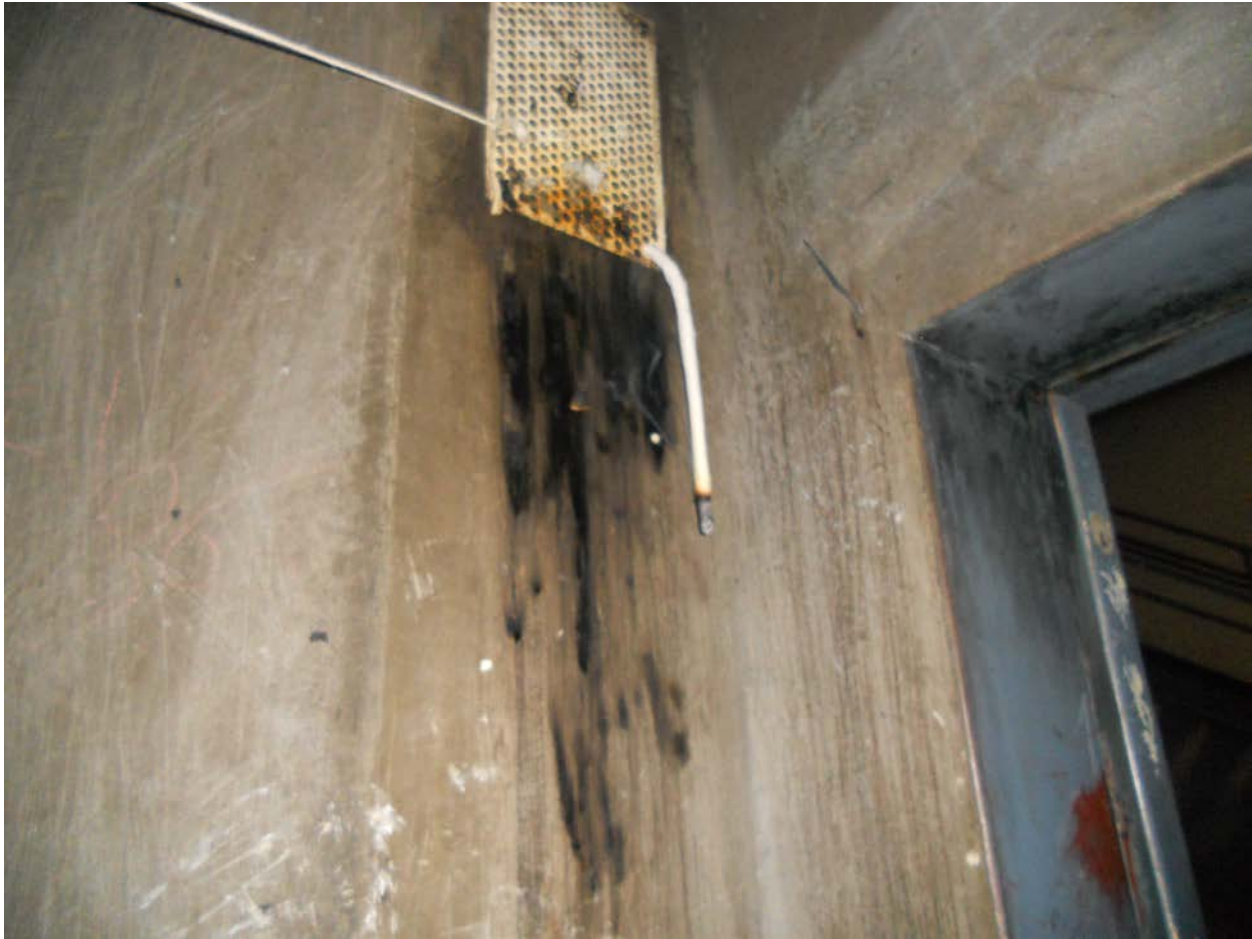
**Photo Exhibit: 23**

Housing Unit 6C: Ventilation grille in Cell 114 (DSCN0957) partially blocked by what appears to be pieces of tissue, with a burning “wick” extending from an intake air vent. The strong odor of burning debris and smoke was discernible throughout the housing units, and was particularly strong in housing units 5 and 6. The amount of soot on the wall below the vent and doorjamb clearly indicates that this is an ongoing practice rather than an isolated incident. The prevalent smoke odor combined with the observations of numerous burning or burned items throughout the housing units clearly indicates inadequate fire safety practices at EMCF, placing inmates and officers at serious risk of fire related injury. Furthermore, there is a clothesline attached to the vent cover, which is indicative of washing clothing and linens inside the cell, rather than sending them to the laundry.

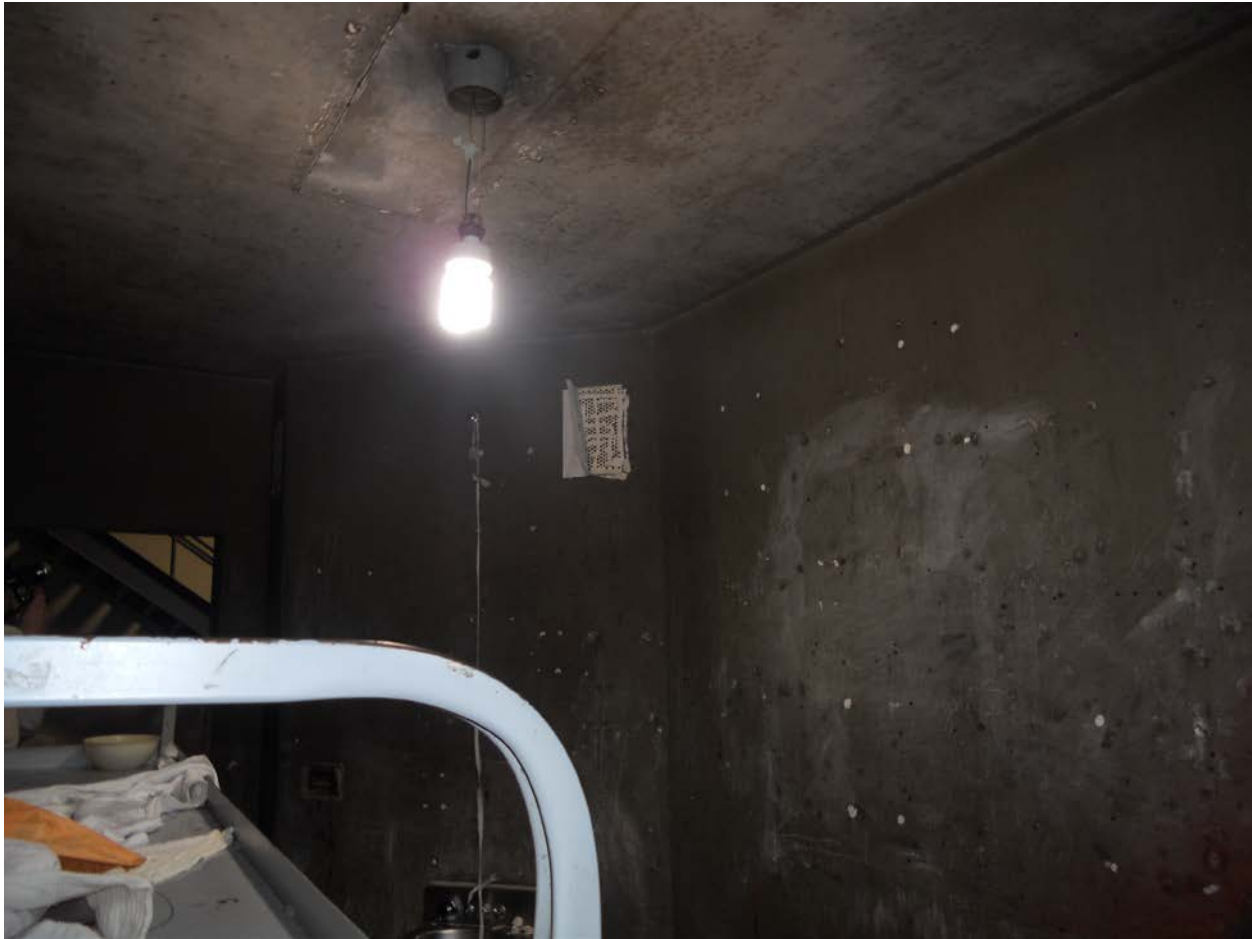
**Photo Exhibit: 24**

Housing Unit 6A: Blocked ventilation grille, exposed light bulb hanging by electrical wires, and clothesline hanging from the fire sprinkler head in Cell 104 (DSCN1139). This photo represents the general condition of many of the cells in units 5 and 6. The blocked vent grille, exposed light bulb and wiring, and obstructed fire sprinkler head are violations of fire safety standards, placing prisoners and staff at risk of fire-related injury. Additionally, the dark, unfinished surface of the ceiling and walls are not smooth and easily cleanable and do not adequately reflect light, exacerbating the problem of insufficient illumination. The white dots on the walls appear to be toothpaste residues. The toothpaste poses a health risk as it attracts insects, including roaches that carry disease-causing microorganisms. The cell lacked a safety mirror above the lavatory, as did all cells in units 5 and 6. Safety mirrors facilitate personal hygiene, especially shaving.

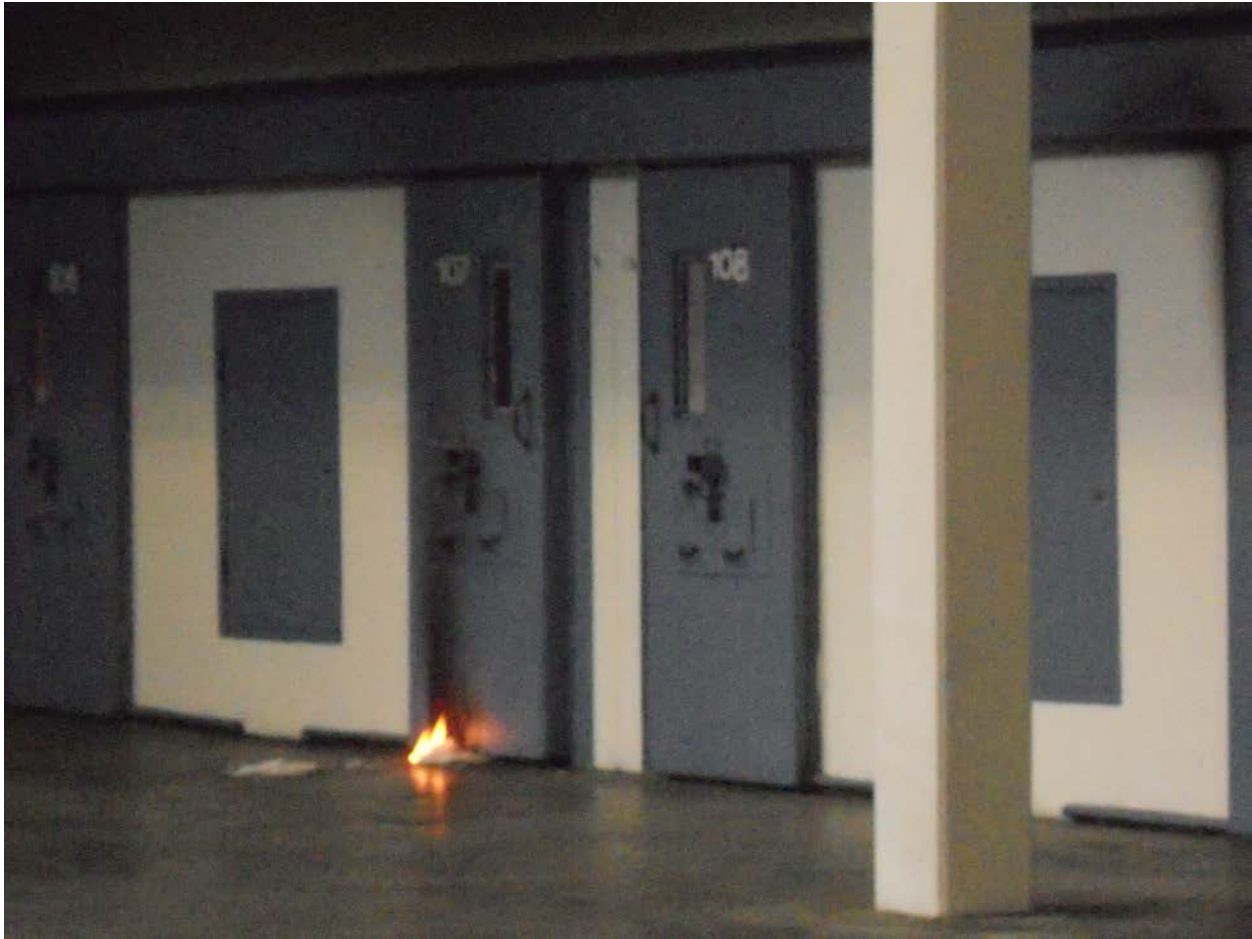
**Photo Exhibit: 25**

Housing Unit 5B: Fire burning outside the door of Cell 107 (DSCN1139). This photograph was taken at approximately 8:42 a.m. The occupant of the cell reportedly set the fire. Fire inside a correctional facility presents a serious danger to both inmates and employees. The soot on the door is also an indicator of previous fires.

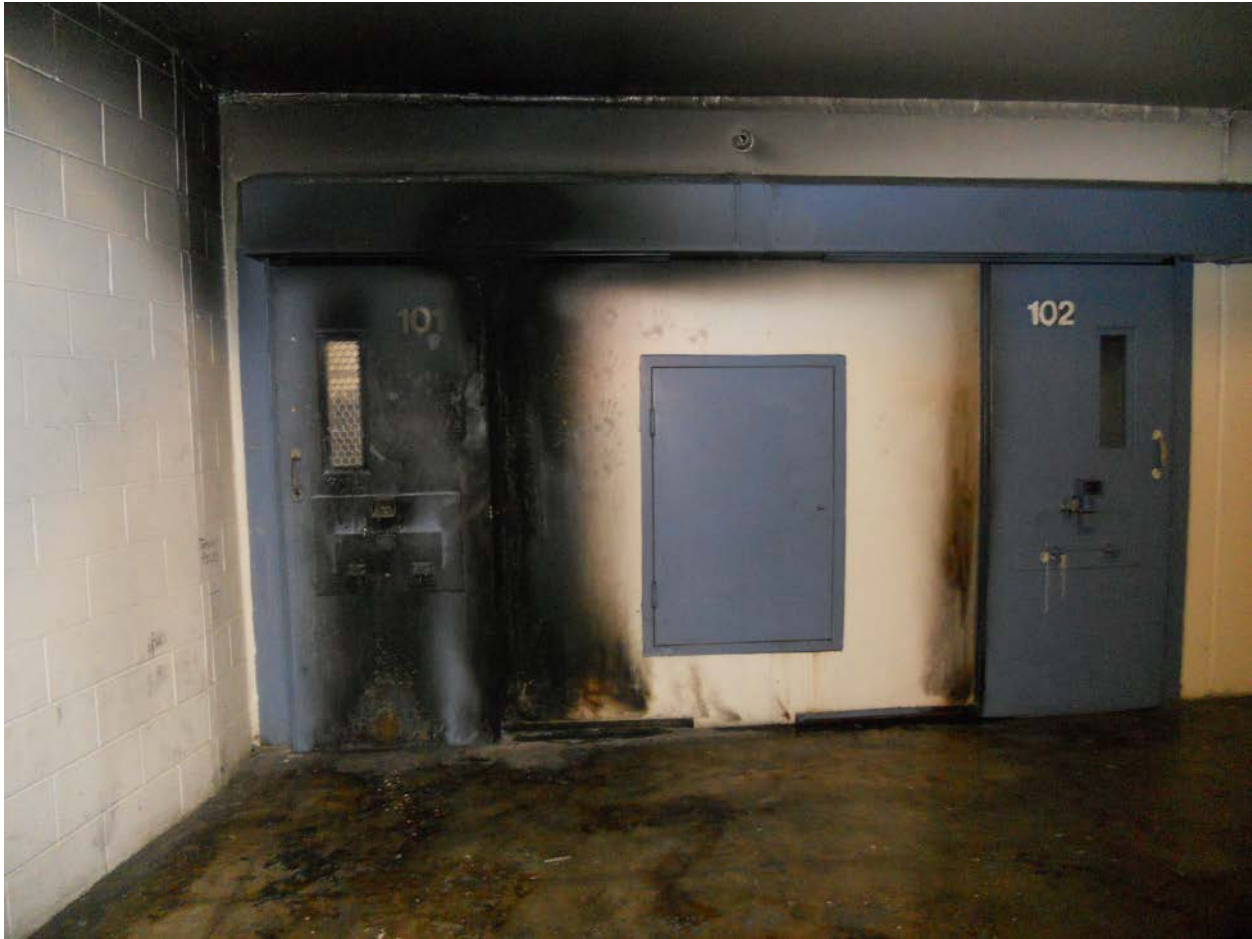
**Photo Exhibit: 26**

Housing Unit 6D: Picture of Cell 101 and 102 doors (DSCN1095). This photograph was taken from the dayroom facing the cells. The soot indicates previous fire incidents. Fire inside a correctional facility presents a serious danger to both inmates and employees.

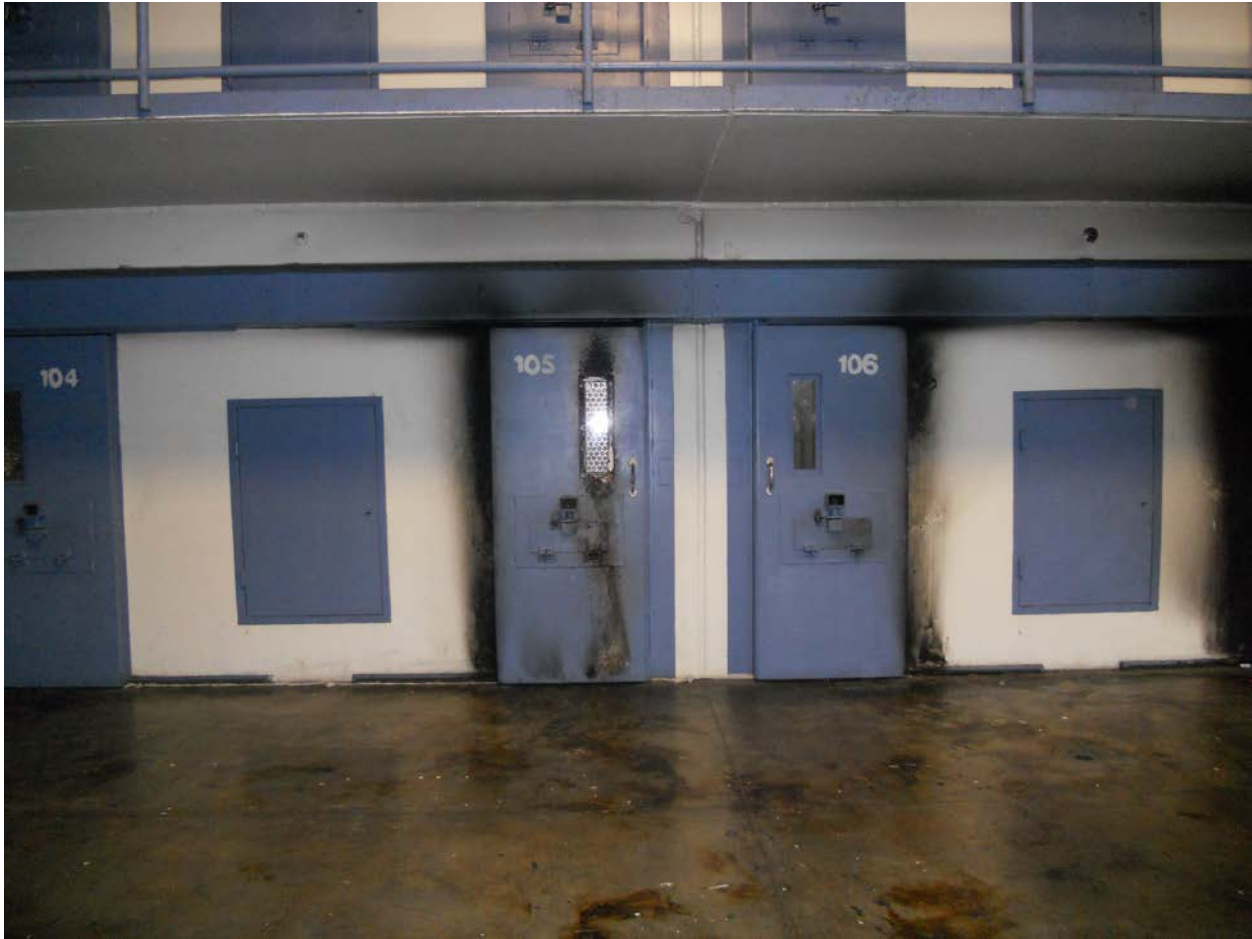
**Photo Exhibit: 27**

Housing Unit 6D: Picture of the doors of Cells 105 and 106 (DSCN1097). This photograph was taken from the dayroom facing the cells. The soot indicates previous fire incidents. Fire inside a correctional facility presents a serious danger to both inmates and employees.

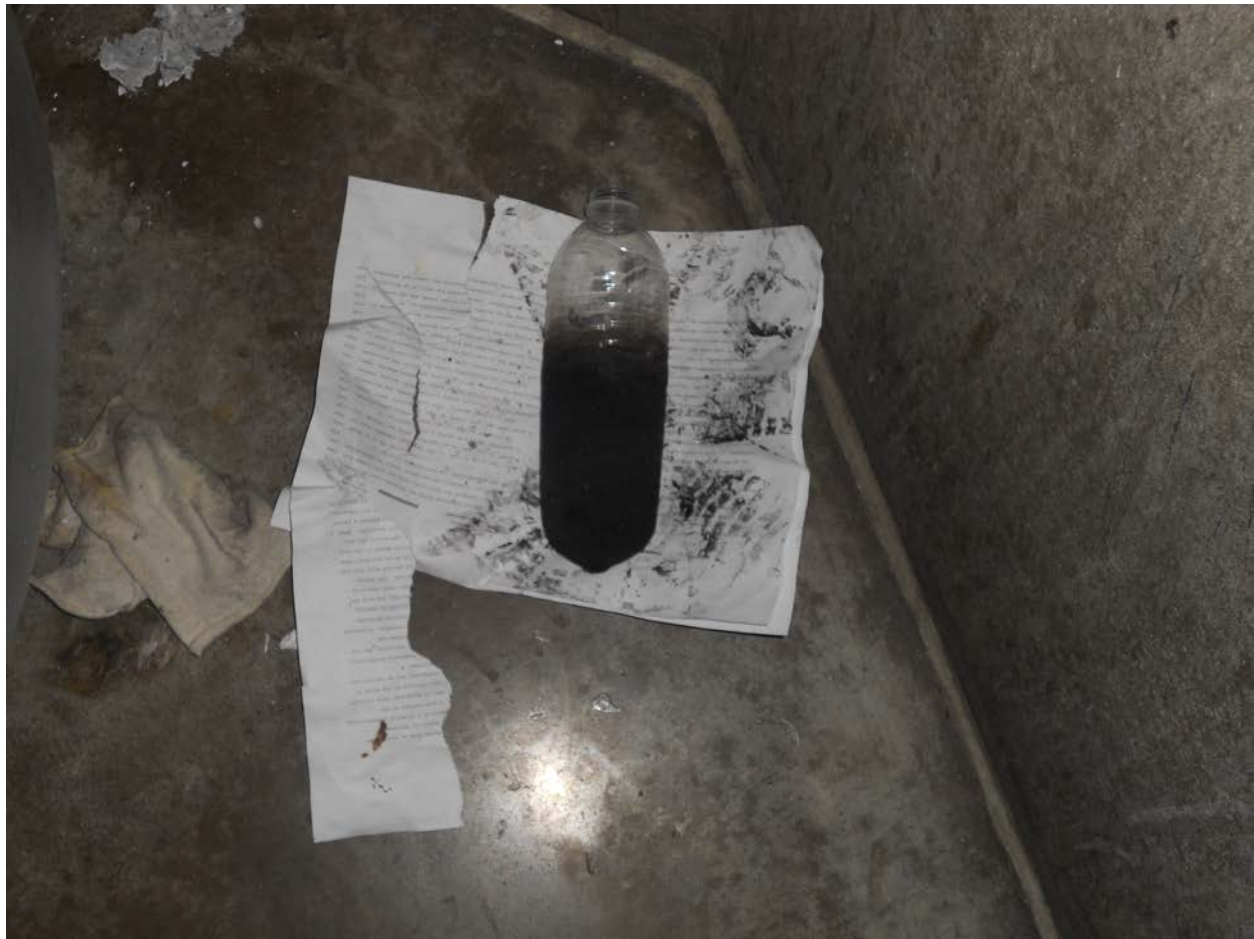
**Photo Exhibit: 28**

Housing Unit 6C: Soot inside a plastic bottle next to the toilet in Cell 214 (DSCN1037). The cell contained a strong odor of smoke and the condition of the bottle clearly indicates an ongoing fire and smoke danger in the inmate housing units.

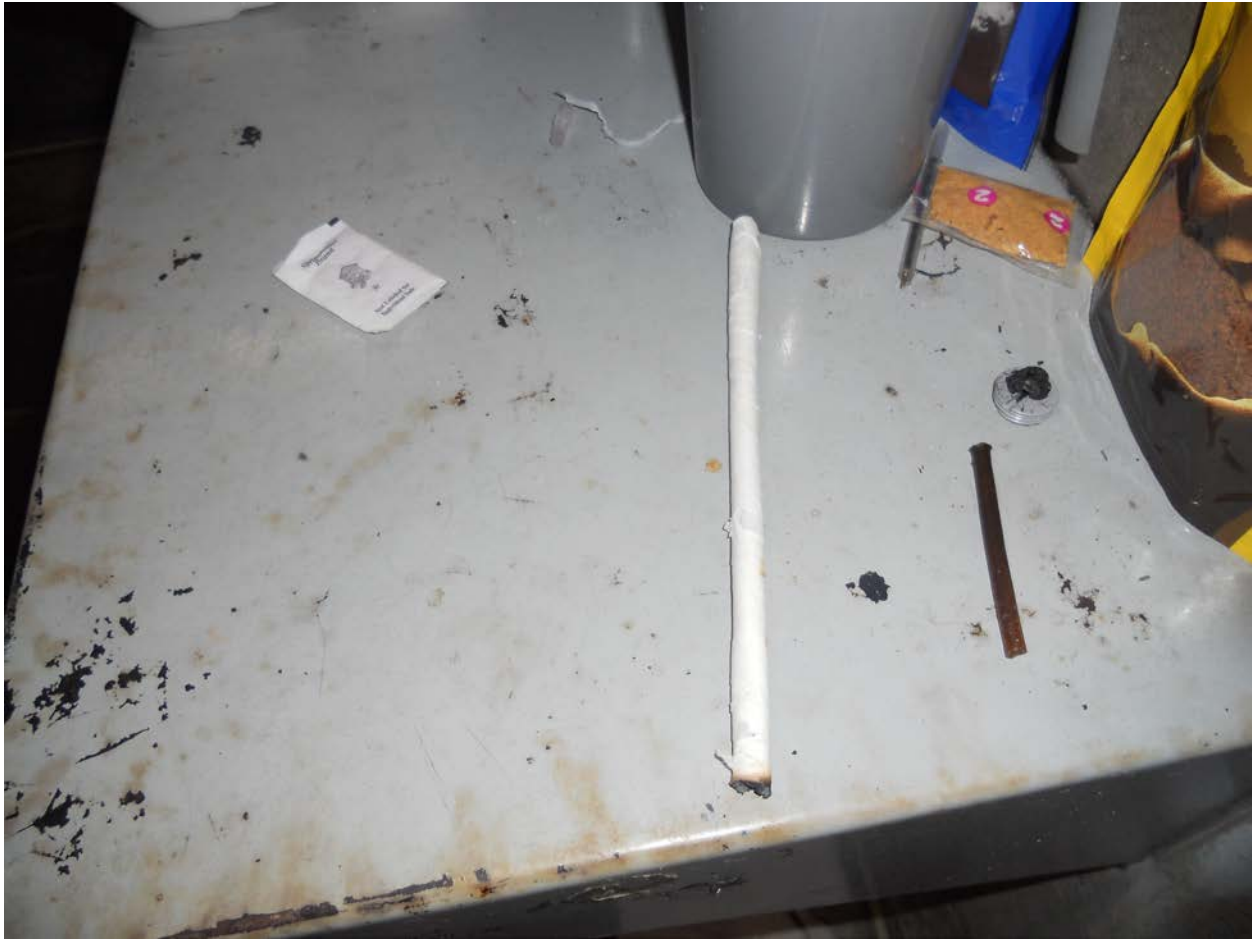
**Photo Exhibit: 29**

Housing Unit 6C: Partially burned wick on cell desk (DSCN1007). This picture was taken in cell 6C-212. Wicks such as this one were found in various cells. It was reported that the wicks are created using toilet tissue and the light socket wiring or a piece of metal wire placed inside a microwave is used to create a spark to light the wick. The wicks are used to light paper or clothing on fire. This picture also depicts the surface of the cell desk, which also functions as the cell dining table. The desk should have a smooth, easily cleanable finish to facilitate cleaning and disinfection necessary to eliminate microorganisms that cause illness.

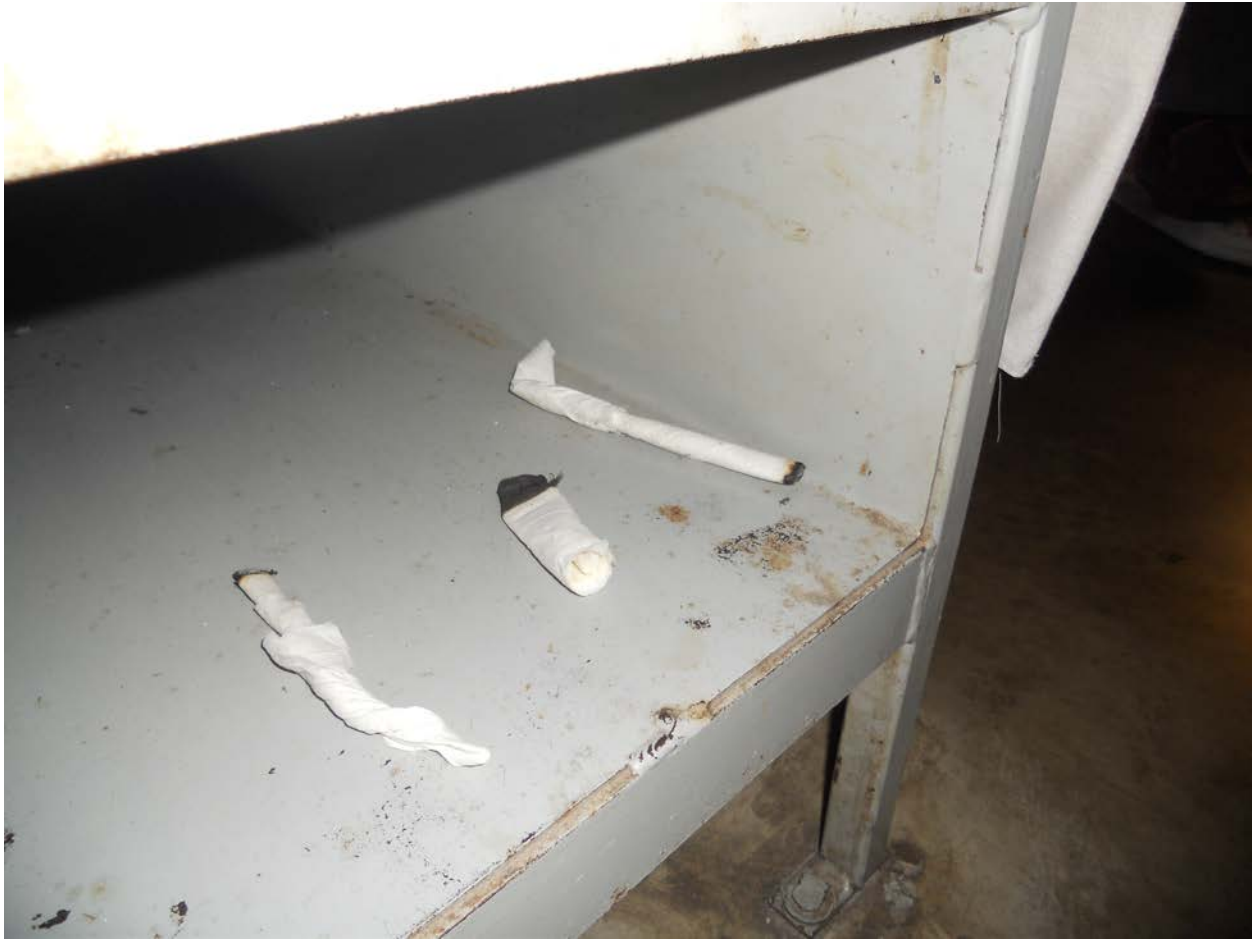
**Photo Exhibit: 30**

Housing Unit 6C: Picture of the Cell 212 bunk and three partially burned wicks (DSCN1021). Inmates reported that the wicks are created using toilet tissue and the light socket wiring or a piece of metal wire placed inside a microwave is used to create a spark to light the wick. The wicks are used to light paper or clothing on fire exposing inmates and staff to fire-related dangers including burns and smoke inhalation.

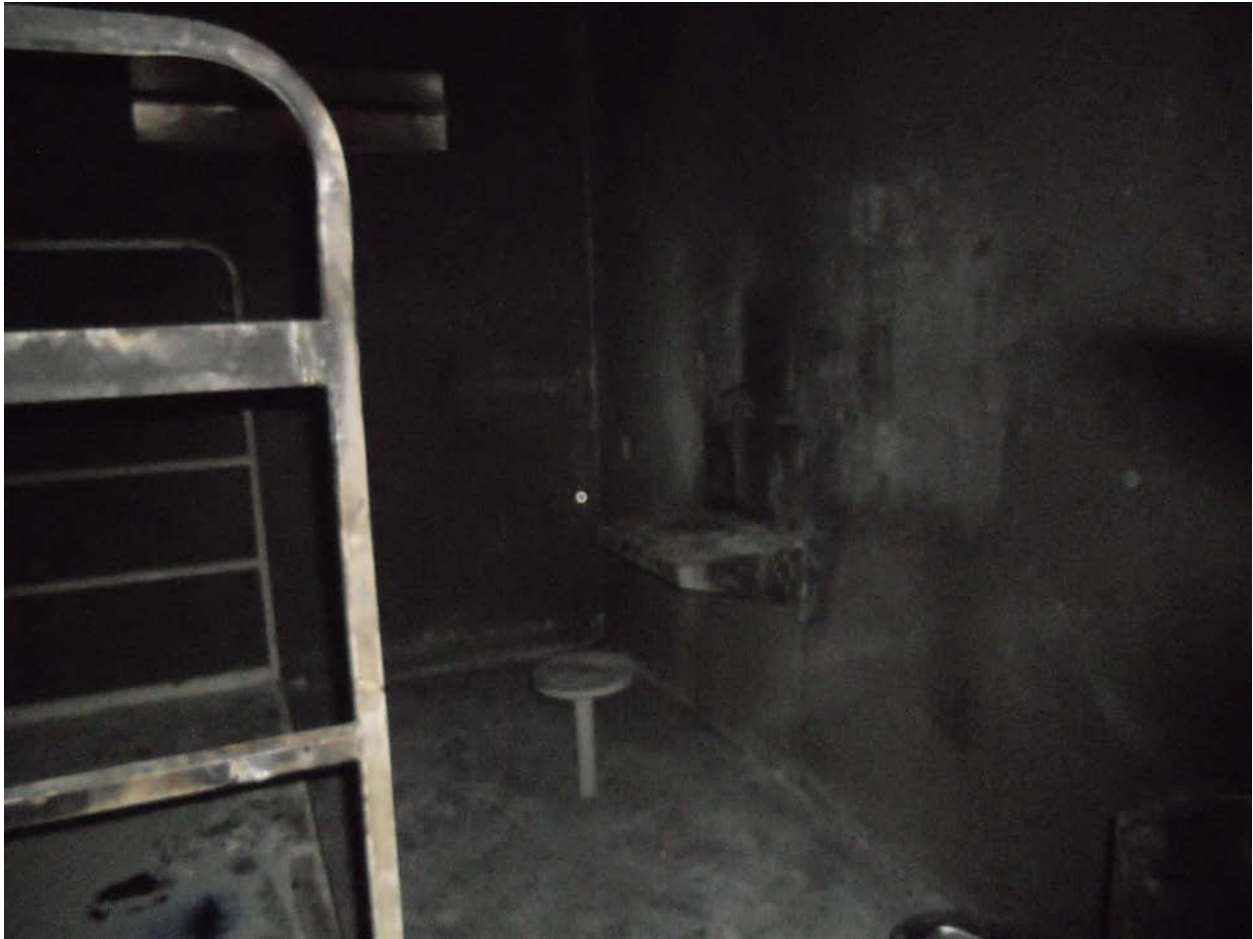
**Photo Exhibit: 31**

Housing Unit 6C: Interior picture of Cell 116 (DSCN0897). The cell was unoccupied. There appeared to have been a significant fire event as the cell was scorched and covered in a layer of ash. A fire appears to have been set on the desk as soot can be seen on the wall above the desk. It is unknown when the event that left the cell in this condition occurred. Please also see Photo Exhibit 32 for a close up picture of the desk and stool.

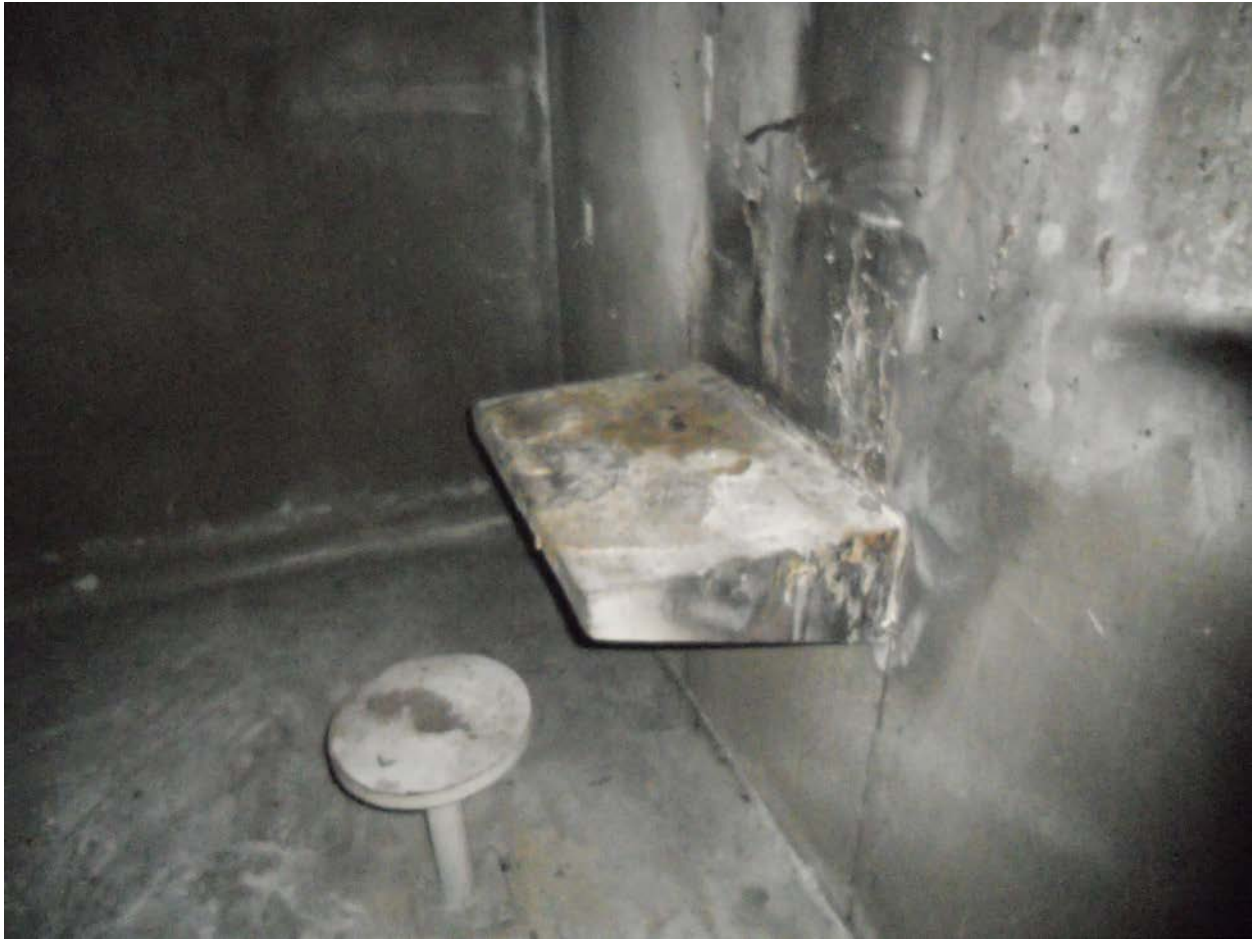
**Photo Exhibit: 32**

Housing Unit 6C: Picture of charred desk and stool in Cell 116 desk and stool (DSCN0898). Please also see Photo Exhibit 31.

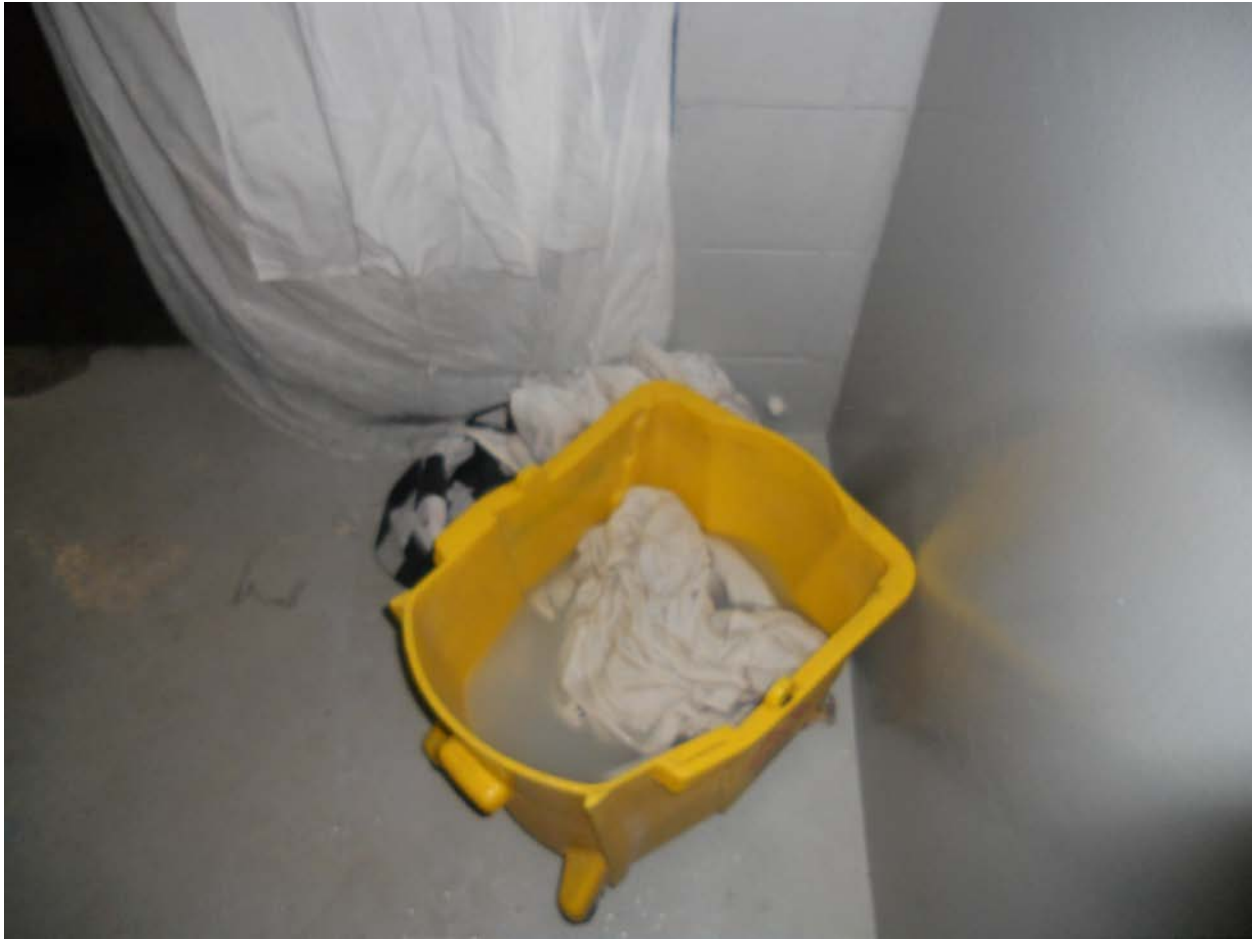
**Photo Exhibit: 33**

Housing Unit 1D: Mop bucket containing a bleach solution being utilized to hand wash personal inmate laundry, in the lower shower area (DSCN1325). The practice of washing personal clothing in mop buckets that are also used to clean the floors is unsanitary and exposes the inmates to disease organisms that are transferred from the floor to the bucket and ultimately to the inmate through the clothing. Additionally, washing laundry in mop buckets lacks the hot water temperatures, as well as the proper detergent and bleach levels provided by the commercial laundering process, and therefore may not result in the complete destruction of disease-causing organisms.

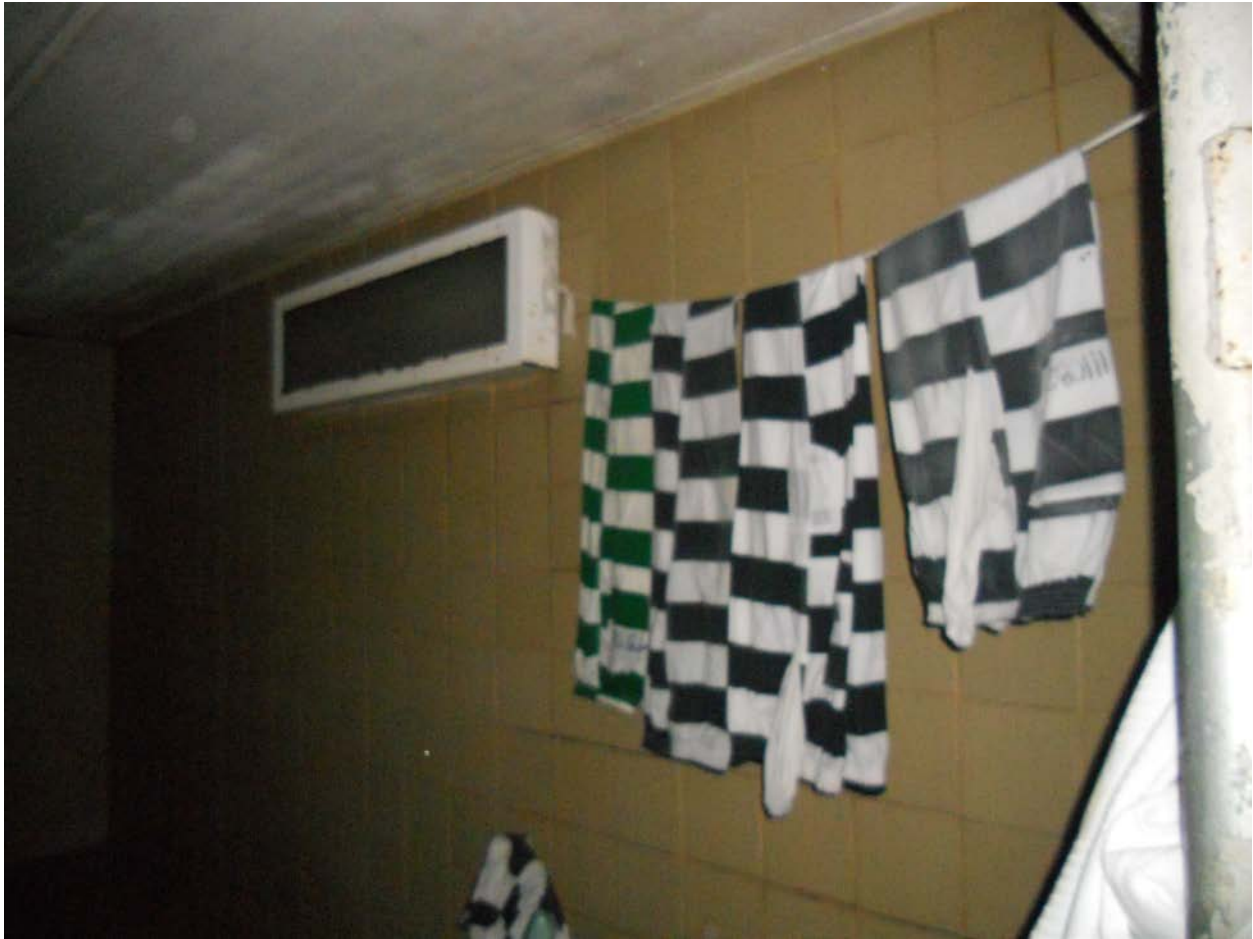
**Photo Exhibit: 34**

Housing Unit 2C: Clothesline in Lower Shower area (DSCN1287). Washing laundry in showers, toilets, sinks, and mop buckets lacks the hot water temperatures, as well as the proper detergent and bleach levels provided by the commercial laundering process, and therefore may not result in the complete destruction of disease-causing organisms. Additionally, the light was not working in the shower room, resulting in an illumination level of 0.4 to 0.6 foot candles, well below the 20 foot candle minimum required by the APHA standard for washrooms. The dimly-lit shower also presents a safety and security hazard, increasing the risk of accidental injury and the threat of violence.

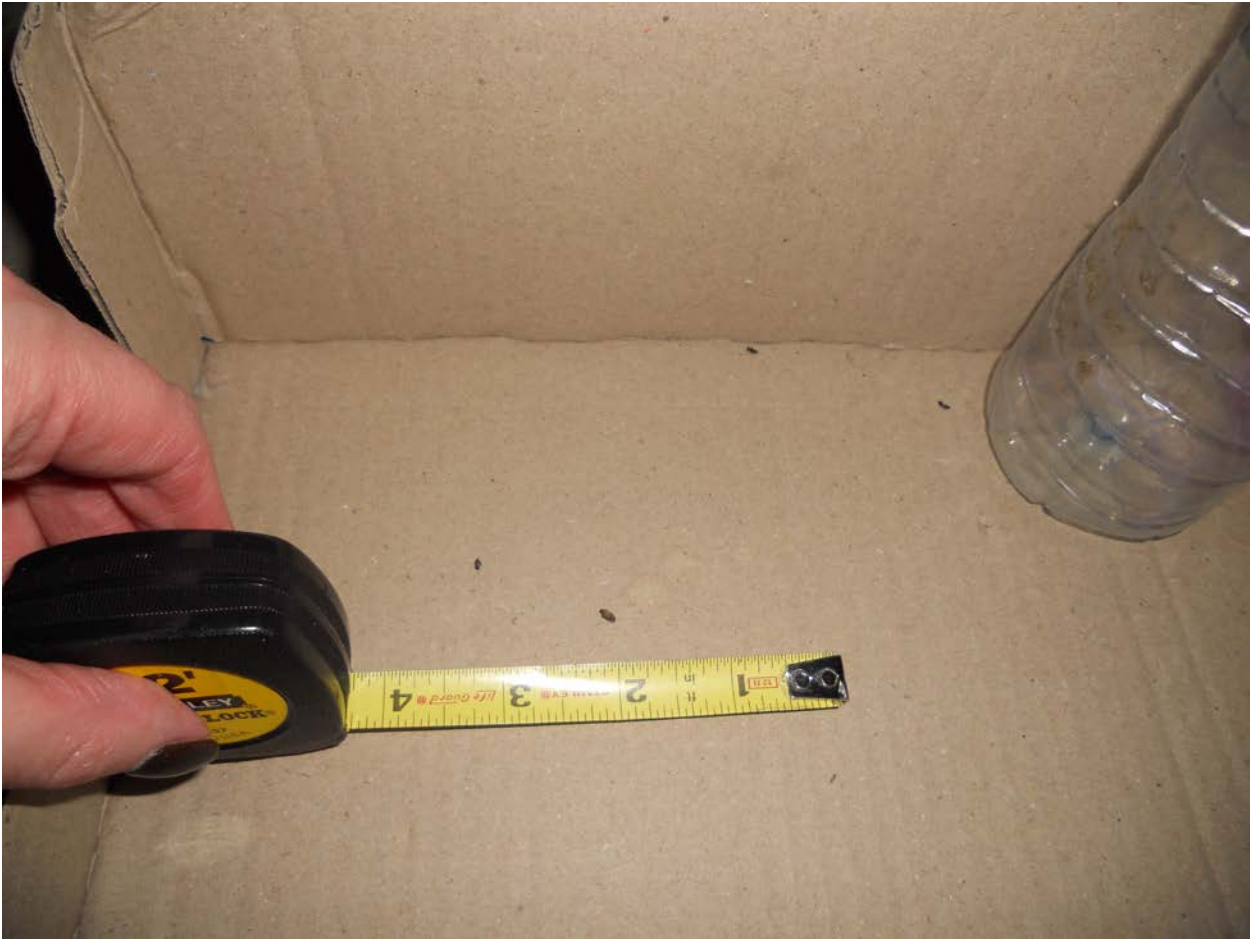
**Photo Exhibit: 35**

Housing Unit 6C: Mouse droppings observed in a cardboard box in Cell 209 (DSCN0988). Mice can transmit a number of bacteriological and viral diseases, including Salmonellosis caused by eating food or drinking water contaminated with rodent feces.
