Environmental Health Inspections  
East Mississippi Correctional Facility  
Meridian, Mississippi  
March 31, 2014 through April 3, 2014

June 13, 2014

Prepared by:  
**Diane Skipworth, R.D., L.D., R.S., CLLM**

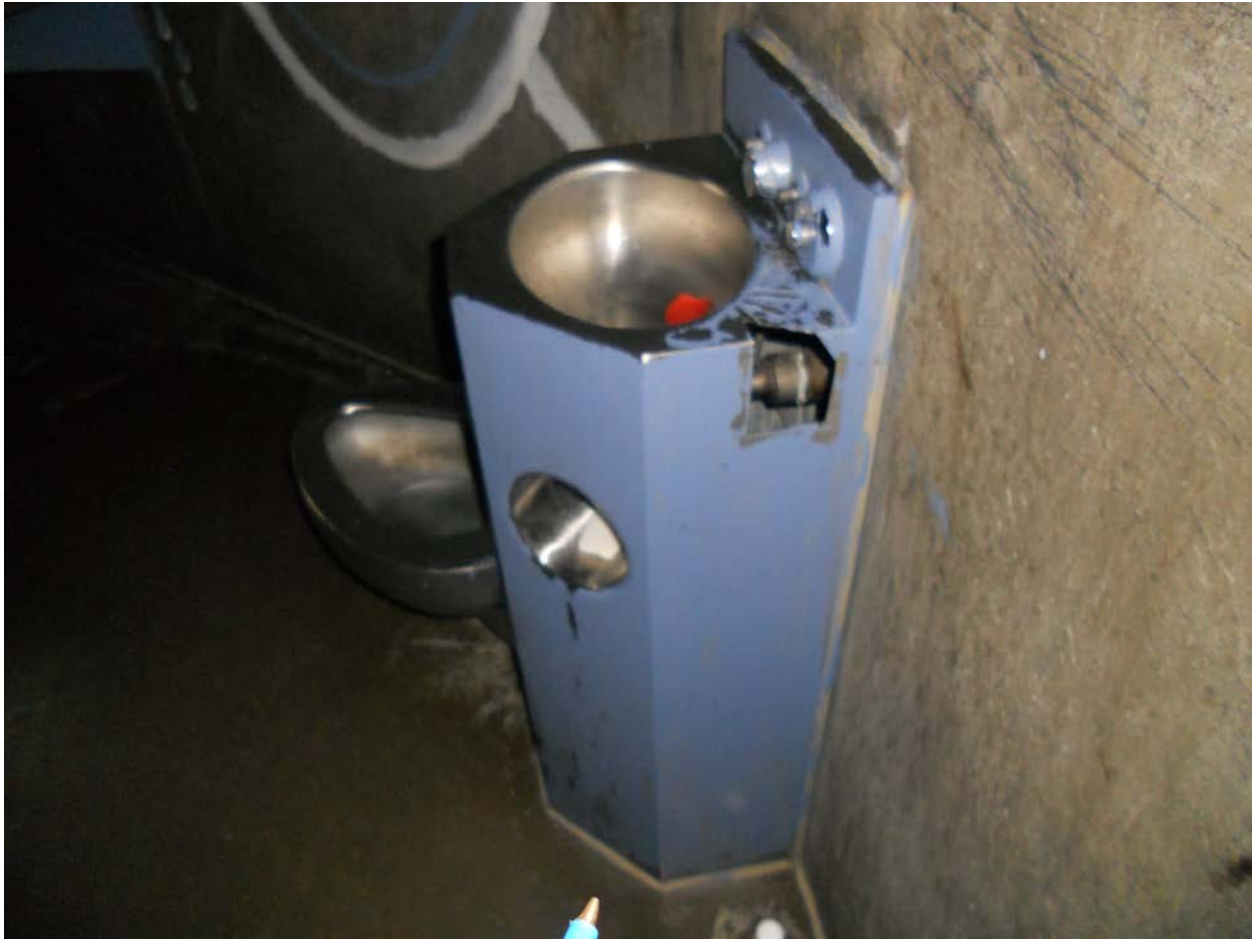
**Photo Exhibit: 36**

Housing Unit 6C: Combination toilet/lavatory unit in Cell 209 (DSCN0994). Holes such as the one pictured here allow the entry of rodents into the housing unit. Mouse droppings were observed in this cell (Photo Exhibit 35).

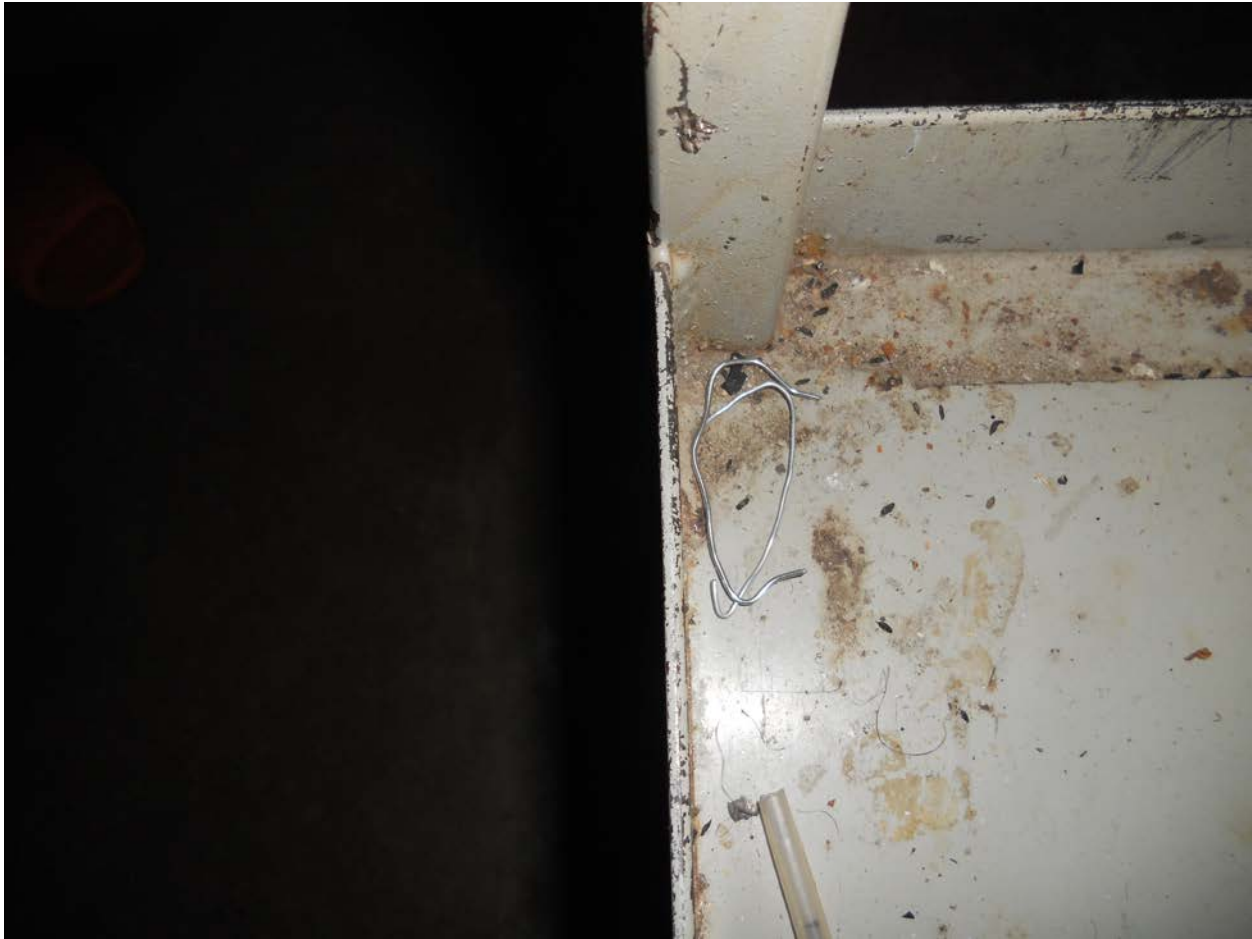
**Photo Exhibit: 37**

Housing Unit 6C: Mouse droppings observed on the bunk in Cell 210 (DSCN1000). Mice droppings and urine can transmit bacteriological and viral diseases to humans. Additionally, the bunk is dirty with an accumulation of food debris and dirt. The wire in the corner of the bunk is contraband and poses a safety and security threat.

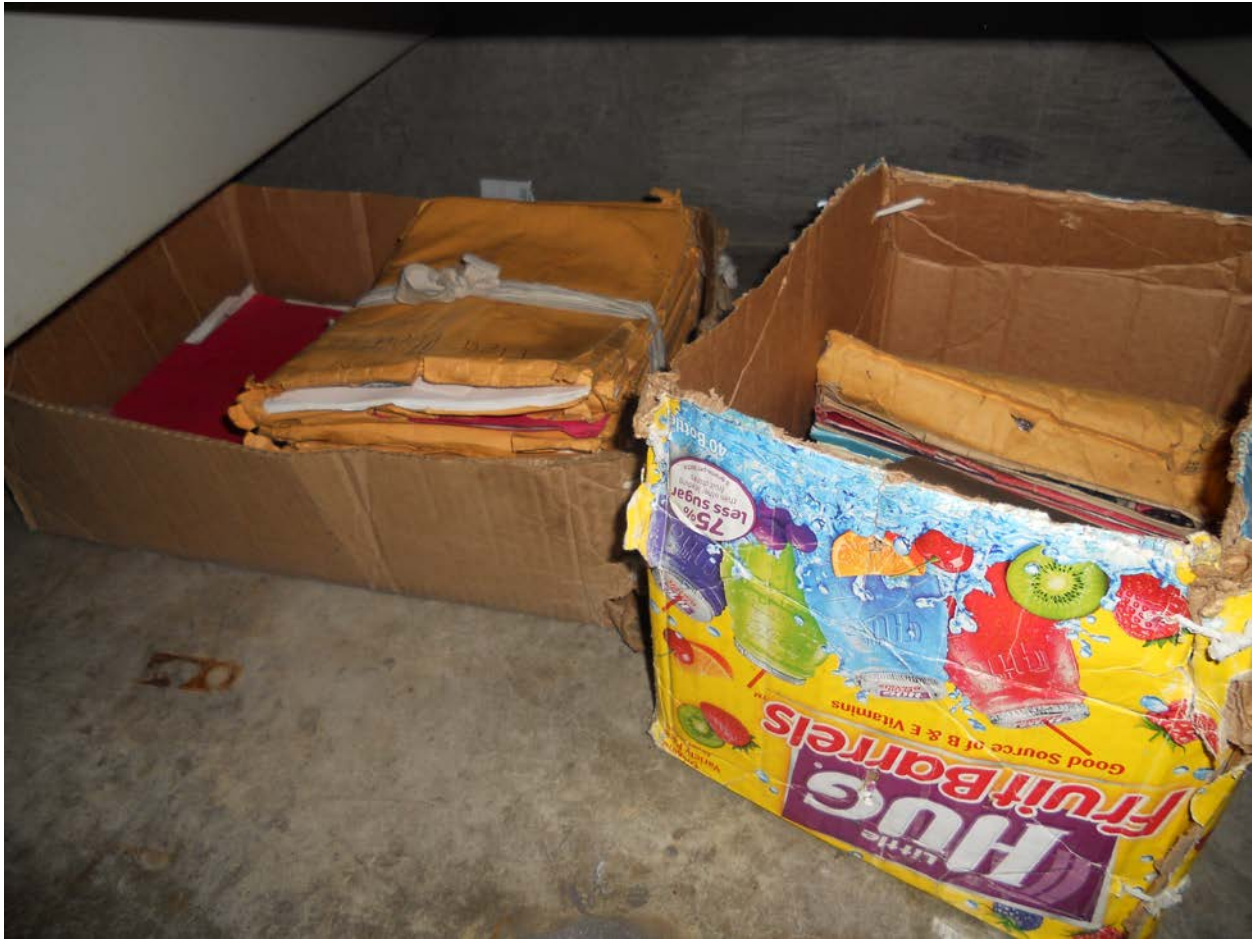
**Photo Exhibit: 38**

Housing Unit 6C: Boxes on the floor in Cell 105 (DSCN0961). The boxes present an ideal harborage location for insects and rodents. The occupant of the cell reported that he has seen small field mice in his cell. Mouse droppings were observed in Cells 6C-209 and 6C-210 in the same housing unit. Mice are known to transmit a number of bacteriological and viral diseases to humans.

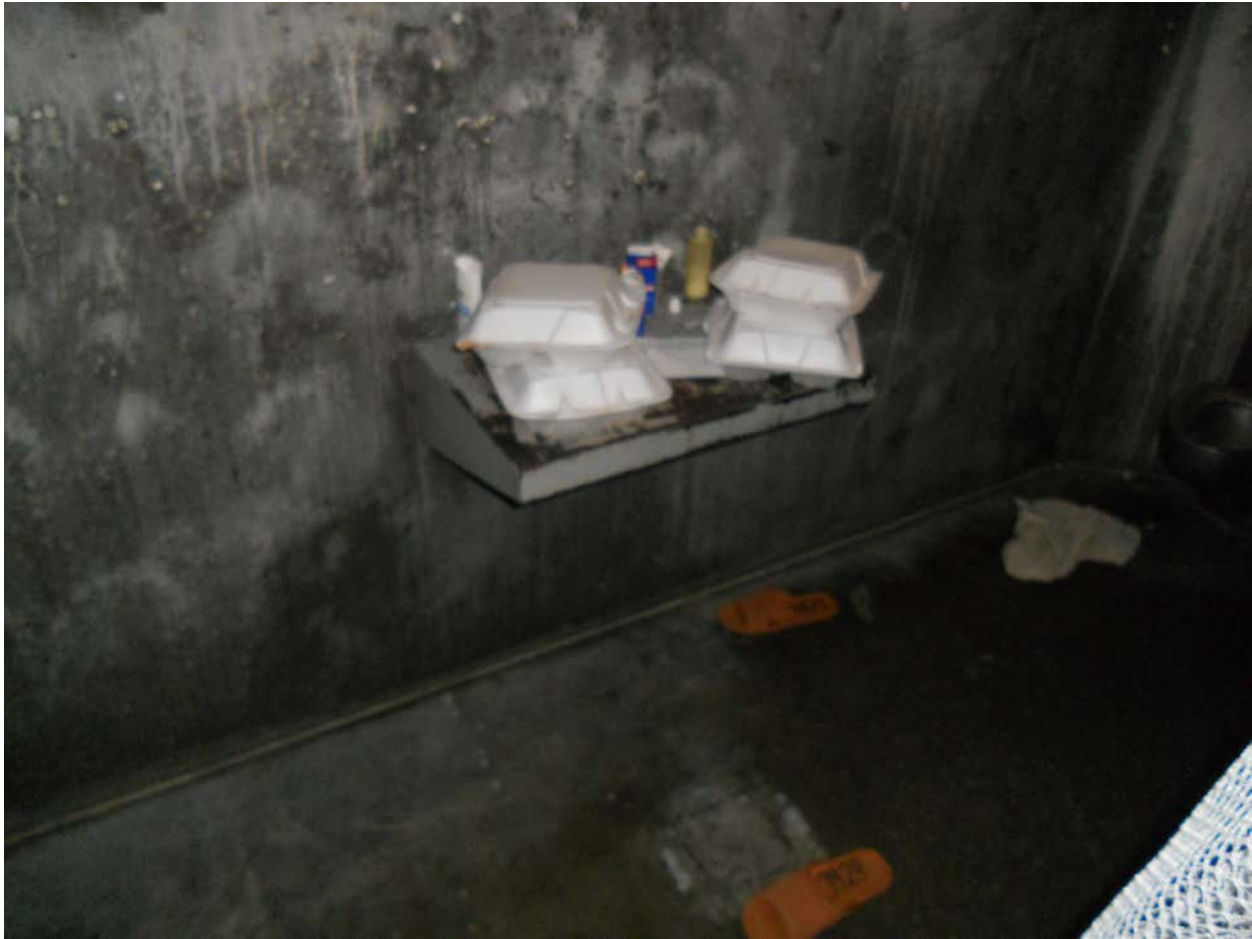
**Photo Exhibit: 39**

Housing Unit 6C: Accumulated meal containers in Cell 215 (DSCN1038). The accumulation of meal containers provides a food source for rodents. Mouse droppings were observed in Cells 6C-209 and 6C-210 in the same housing unit. The kitchen provides the Styrofoam containers and one container is served for each meal. Mice are a danger as they can transmit bacteriological and viral diseases to humans. Also, note the dirty condition of the desk, wall, and floor. Furthermore, the paint is chipped on the desk, creating a surface that is not smooth and easily cleanable. Additionally, the stool is missing; this cell affords no place to sit other than the bunk.

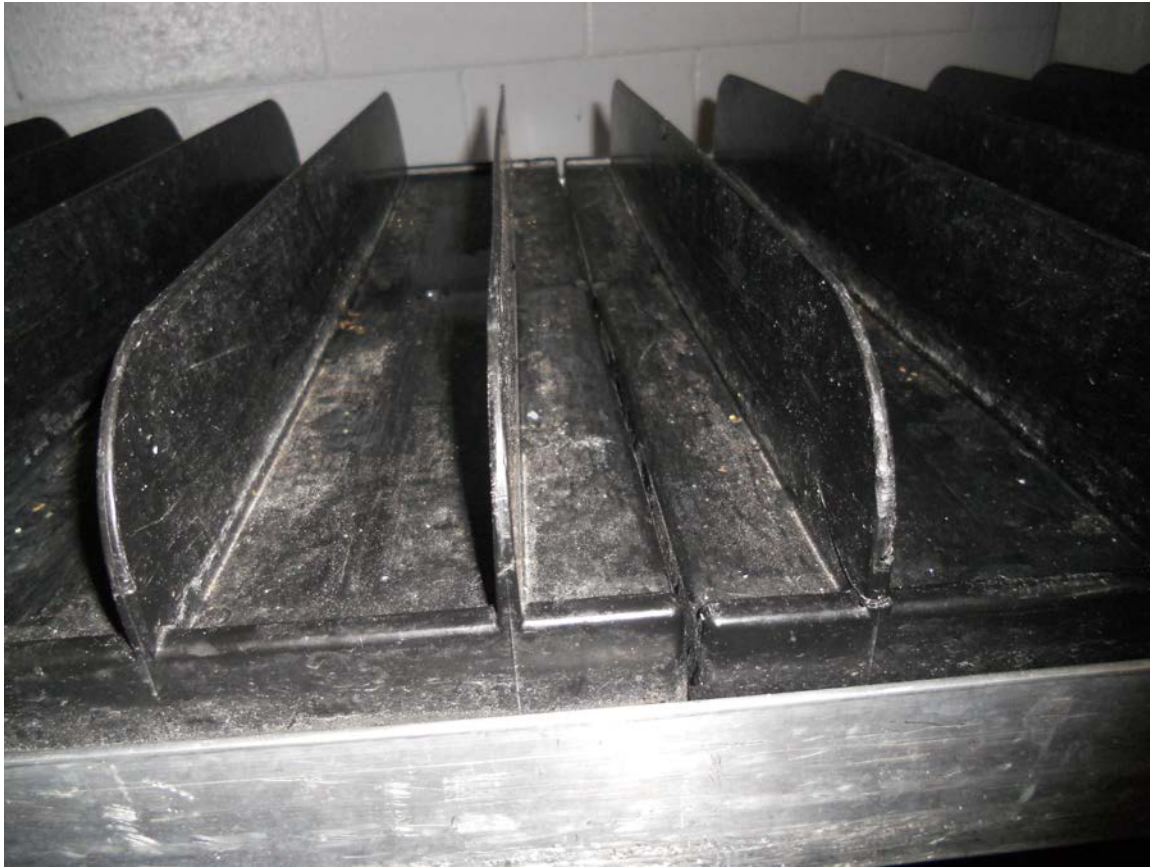
**Photo Exhibit: 40**

FDA Food Code Violation: 4-903.11

Cleaned equipment and utensils shall be stored in a clean, dry location, where they are not exposed to splash, dust, or other contamination.

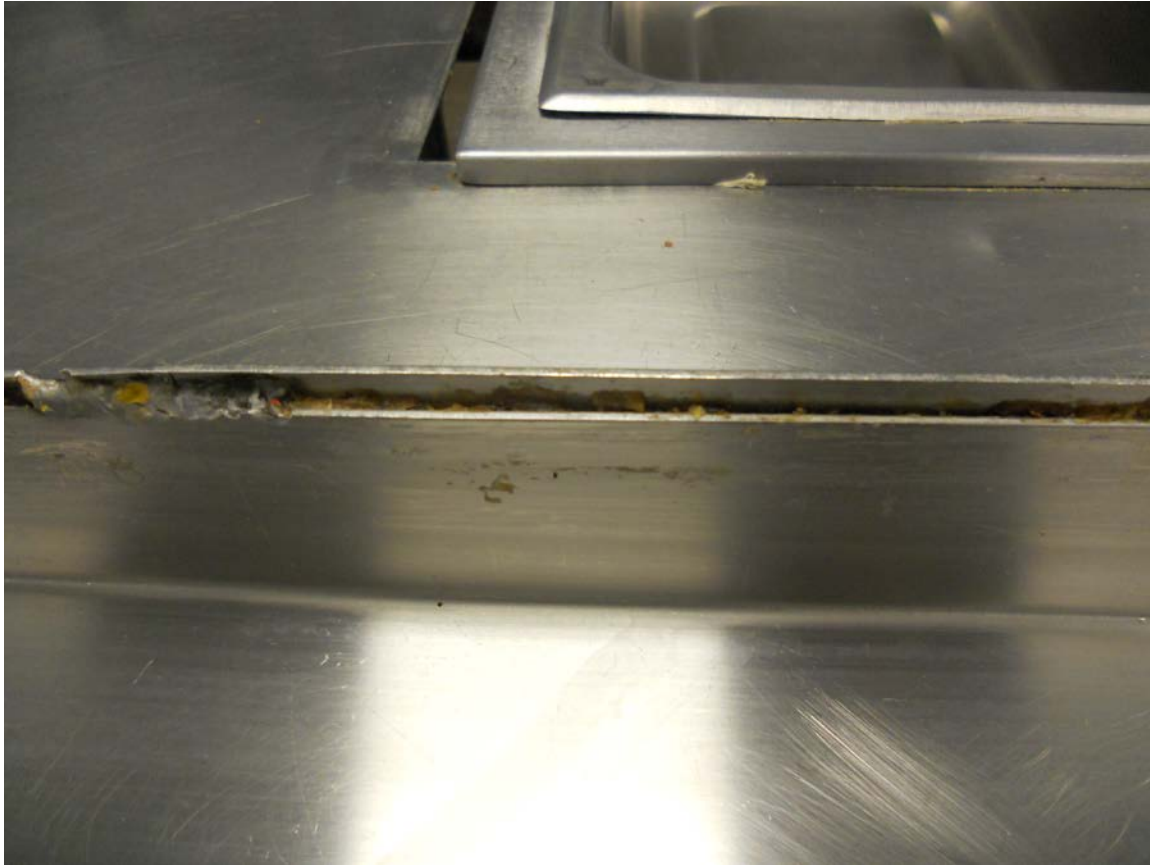
**Photo Exhibit: 41**

Nonfood-contact surfaces of equipment shall be cleaned at a frequency to preclude accumulation of soil residues.

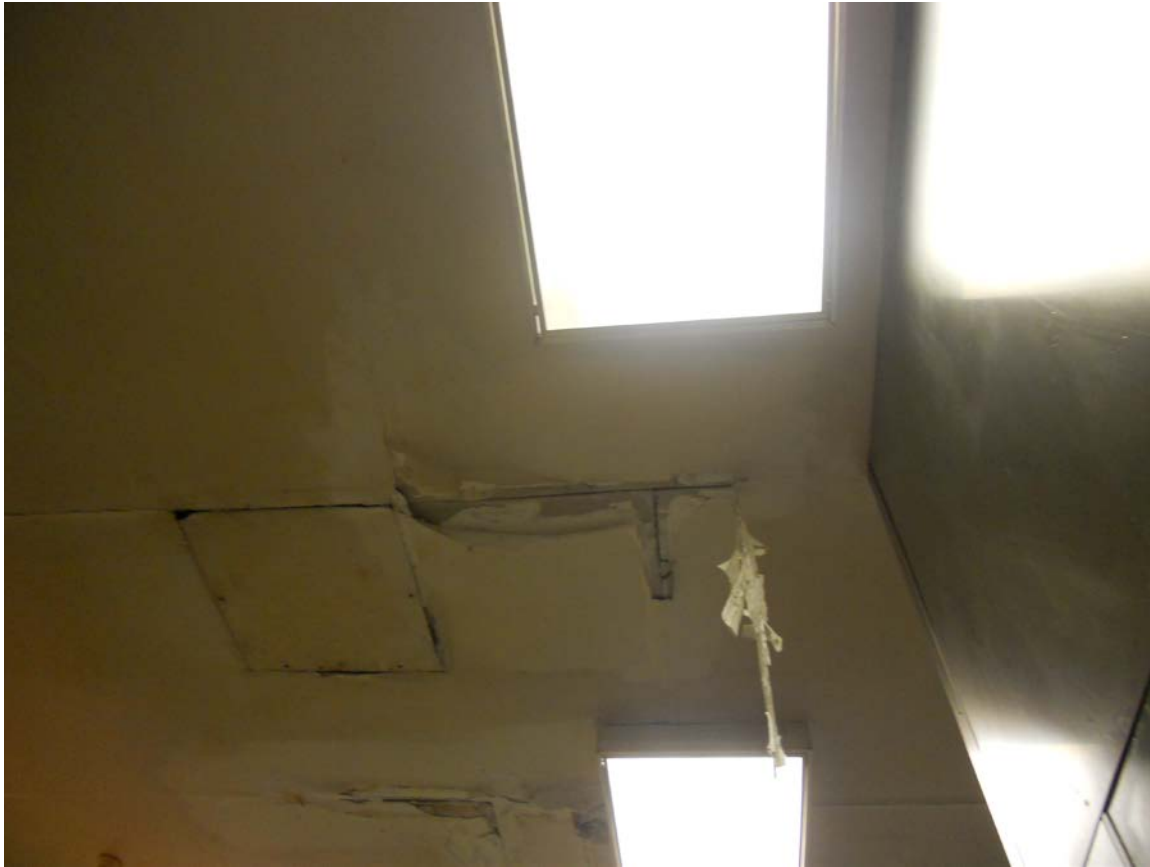
**Photo Exhibit: 42**

Kitchen: Kitchen ceiling (DSCN0592) above the grill and kettle food preparation areas, and near the clean unloading end of the flight type dishwasher utilized to wash the meal trays and food service utensils. The area presents a serious contamination risk, as loose and hanging debris may fall on food during preparation and cleaned food contact surface areas, such as food trays after they have been washed.

FDA Food Code Violation: 3-305.14

FDA Food Code Violation: 6-101.11

Materials for indoor floor, wall, and ceiling surfaces under conditions of normal use shall be smooth, durable, and easily cleanable for areas where food establishment operations are conducted.

FDA Food Code Violation: 6-501.11

Physical facilities shall be maintained in good repair.

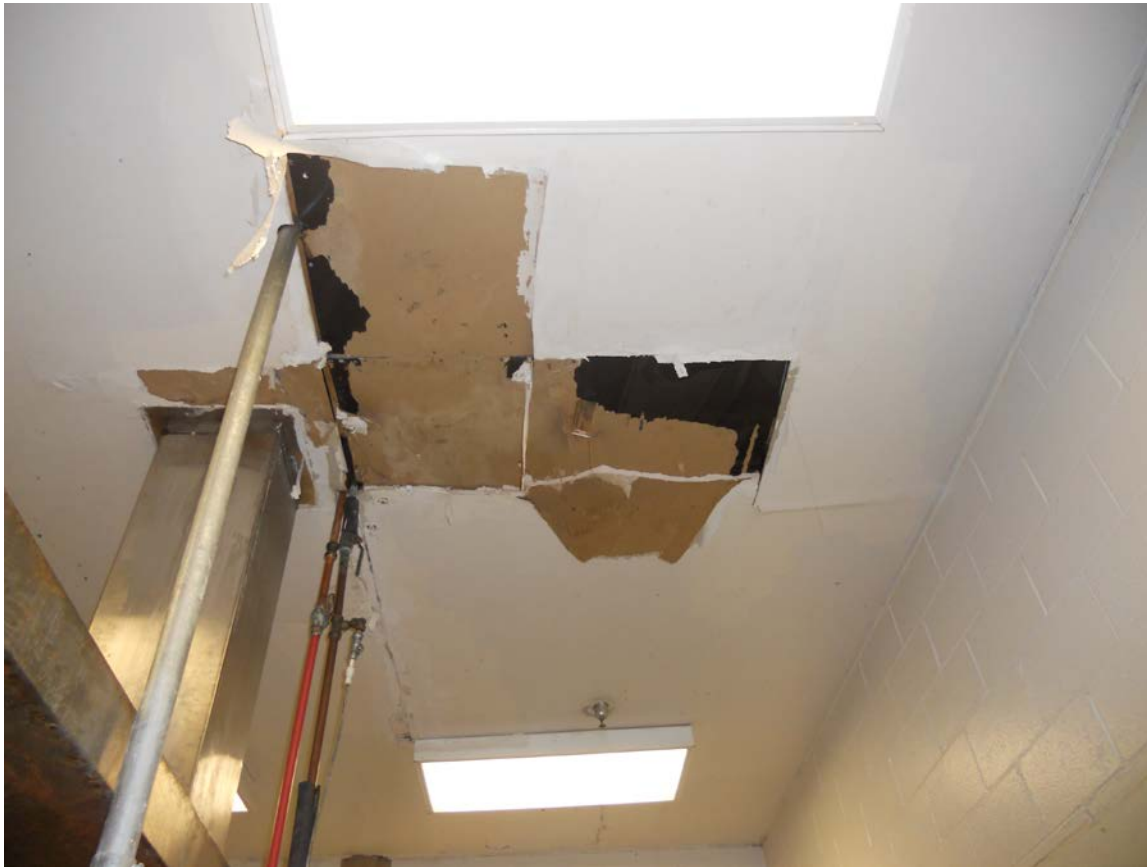
**Photo Exhibit: 43**

Kitchen: Kitchen ceiling (DSCN0598) in the dishwashing area. This area is above the flight-type dishwasher utilized to wash the trays and food service utensils. The area presents a serious contamination risk, as loose debris and condensate drips are likely to fall on cleaned food contact surface areas such as food trays after they have been washed. Additionally, the opening presents a potential entry point for insects, rodents, and other pests.

FDA Food Code Violation: 6-101.11

Materials for indoor floor, wall, and ceiling surfaces under conditions of normal use shall be smooth, durable, and easily cleanable for areas where food establishment operations are conducted.

FDA Food Code Violation: 6-501.11

Physical facilities shall be maintained in good repair.

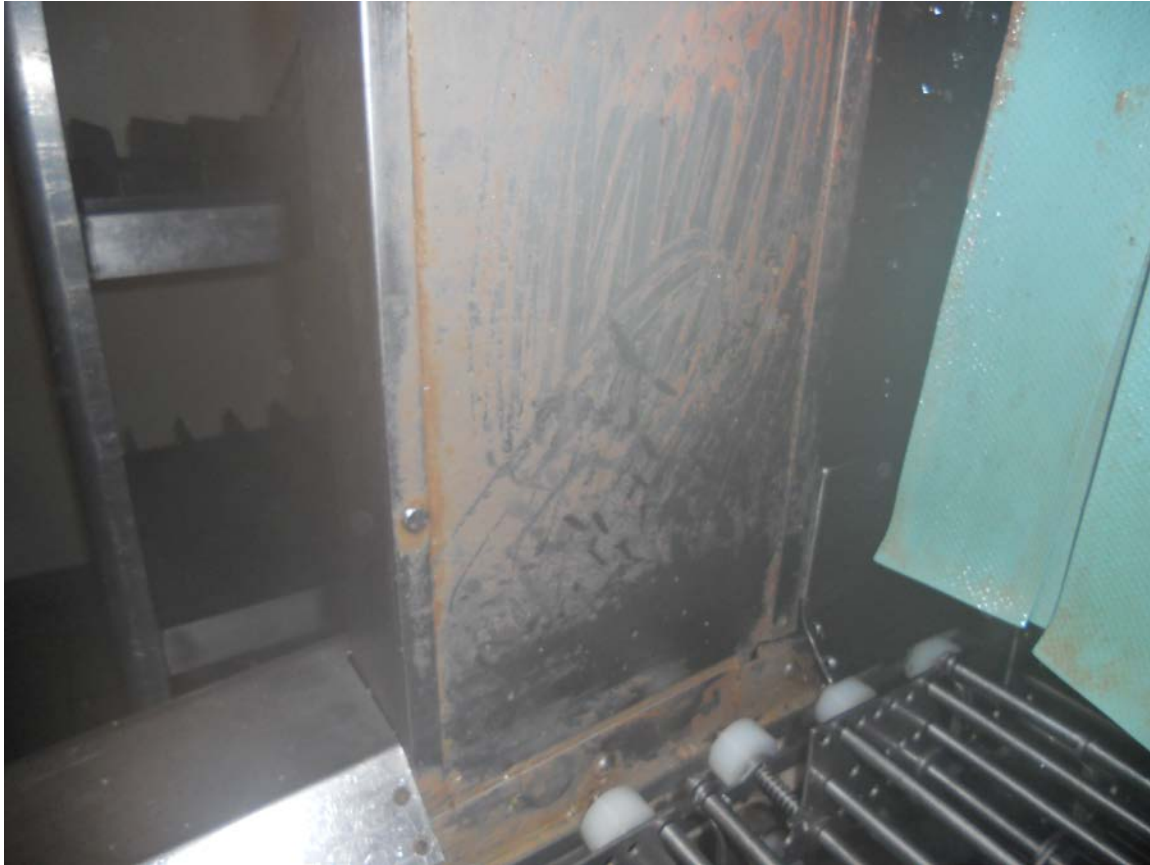
**Photo Exhibit: 44**

Kitchen: Apparent growths of *Serratia marcescens* bacterium (commonly known as “pink slime”) on the entrance of the mechanical dishwasher (DSCN0565). This dishwasher is used to wash trays and food service utensils. This condition presents a cross-contamination risk, as the dishwasher should be maintained in a clean and sanitary manner to ensure the proper washing and sanitizing of wares.

FDA Food Code Violation: 4-501.14

A warewashing machine shall be cleaned before use, throughout the day at a frequency necessary to prevent recontamination of equipment and utensils, and if used, at least every 24 hours.

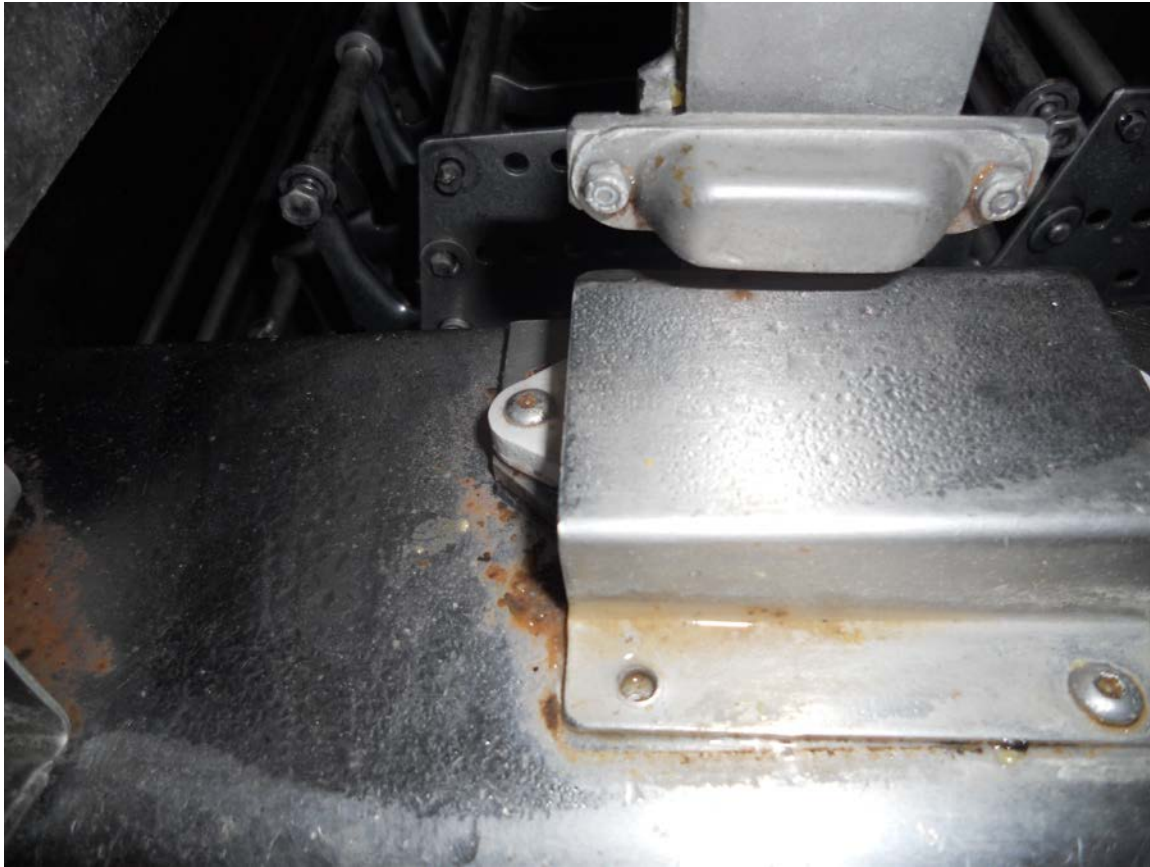
**Photo Exhibit: 45**

Kitchen: Apparent growths of mold and *Serratia marcescens* bacterium on the clean (unloading) end of the mechanical dishwasher (DSCN0602) utilized to wash the trays and food service utensils. This condition presents a contamination risk, as the dishwasher should be maintained in a clean and sanitary manner to facilitate the proper washing and sanitizing of wares. The dishwasher must be cleaned throughout the day to ensure the proper cleaning and sanitization of equipment and utensils, especially as this is the section of the machine where the cleaned and sanitized items are removed from the conveyor belt after they have gone through all the machine cycles. The filthy condition of the machine exposes the cleaned wares to recontamination.

FDA Food Code Violation: 4-501.14

A warewashing machine shall be cleaned before use, throughout the day at a frequency necessary to prevent recontamination of equipment and utensils, and if used, at least every 24 hours.

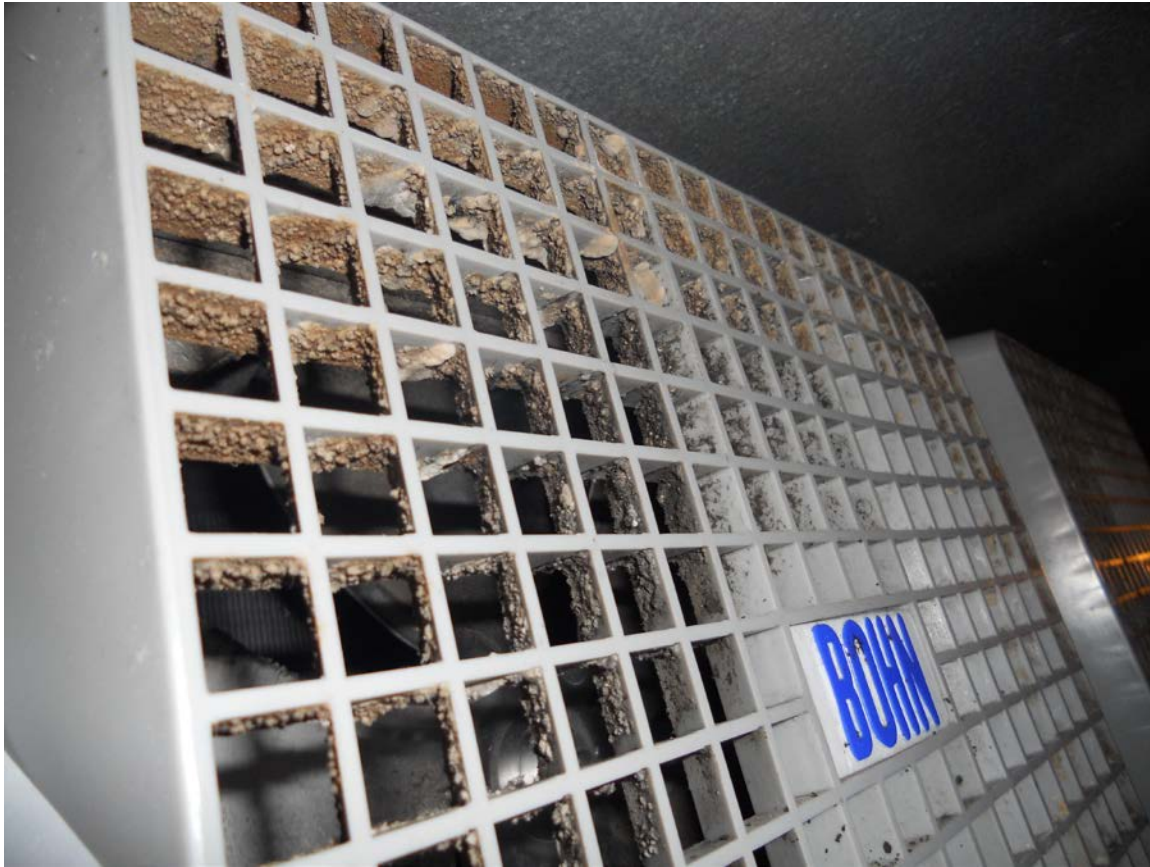
**Photo Exhibit: 46**

Kitchen: Kitchen cooler #2 (DSCN0574). This photo depicts dust build-up on the cover of a fan unit in cooler #2. Boxes and cartons of food are stored in the cooler. The condition of the cover poses a potential hazard as the fan may propel dust containing contaminants and microorganisms onto the food stored below.

FDA Food Code Violation: 3-305.12

Food may not be stored under other sources of contamination.

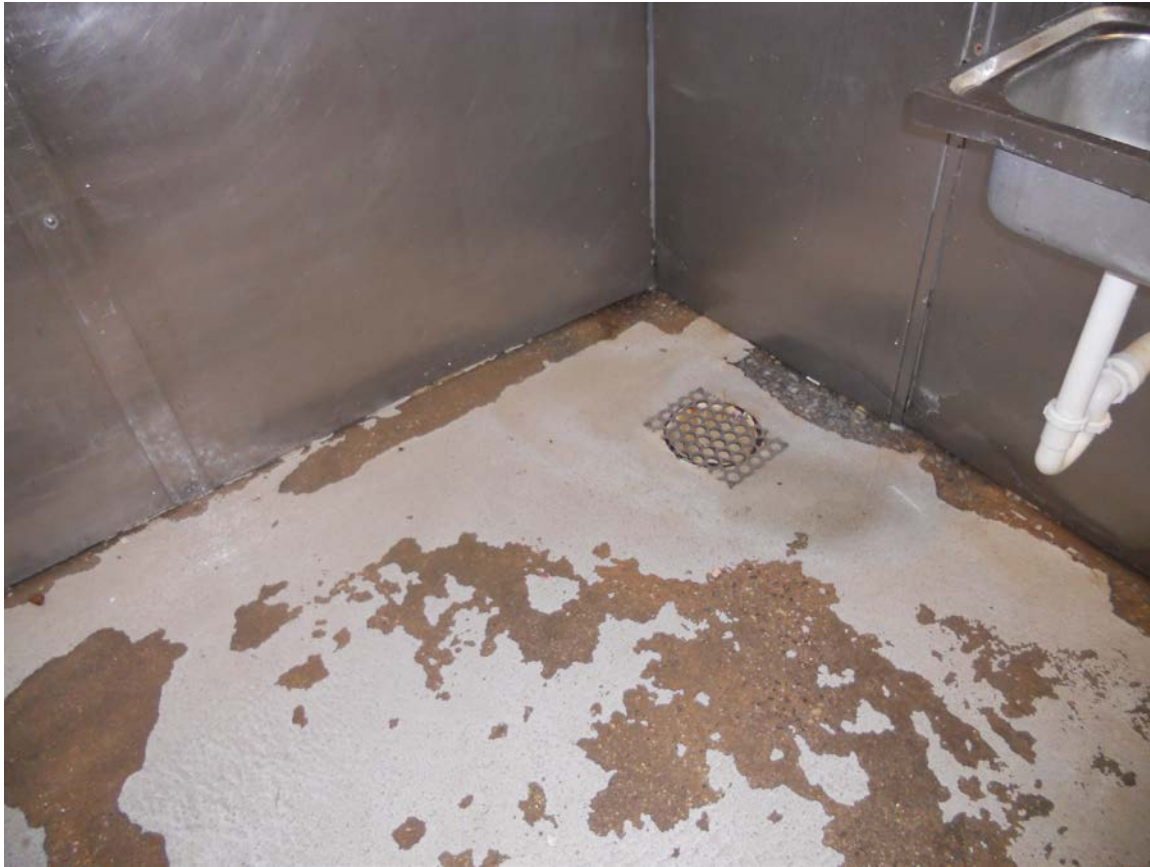
**Photo Exhibit: 49**

Kitchen: Mop wastewater is poured directly into the kitchen floor drain (DSCN0563) pictured here in the corner, near a hand wash sink rather than utilizing the curbed cleaning facility depicted in picture DSCN0558, in the adjacent chemical room (closet). Mop water and liquid wastes are contaminated with microorganisms and other filth. Therefore wastewater must be disposed of in a sanitary manner that will not contaminate food or equipment. The proper use of a curbed cleaning facility or mop sink with a drain allows for safe and proper disposal. Furthermore, the condition of the floor surface inhibits adequate cleaning of the floor.

FDA Food Code Violation: 6-101.11

Materials for indoor floor, wall, and ceiling surfaces under conditions of normal use shall be smooth, durable, and easily cleanable for areas where food establishment operations are conducted.

FDA Food Code Violation: 6-501.11

Physical facilities shall be maintained in good repair.

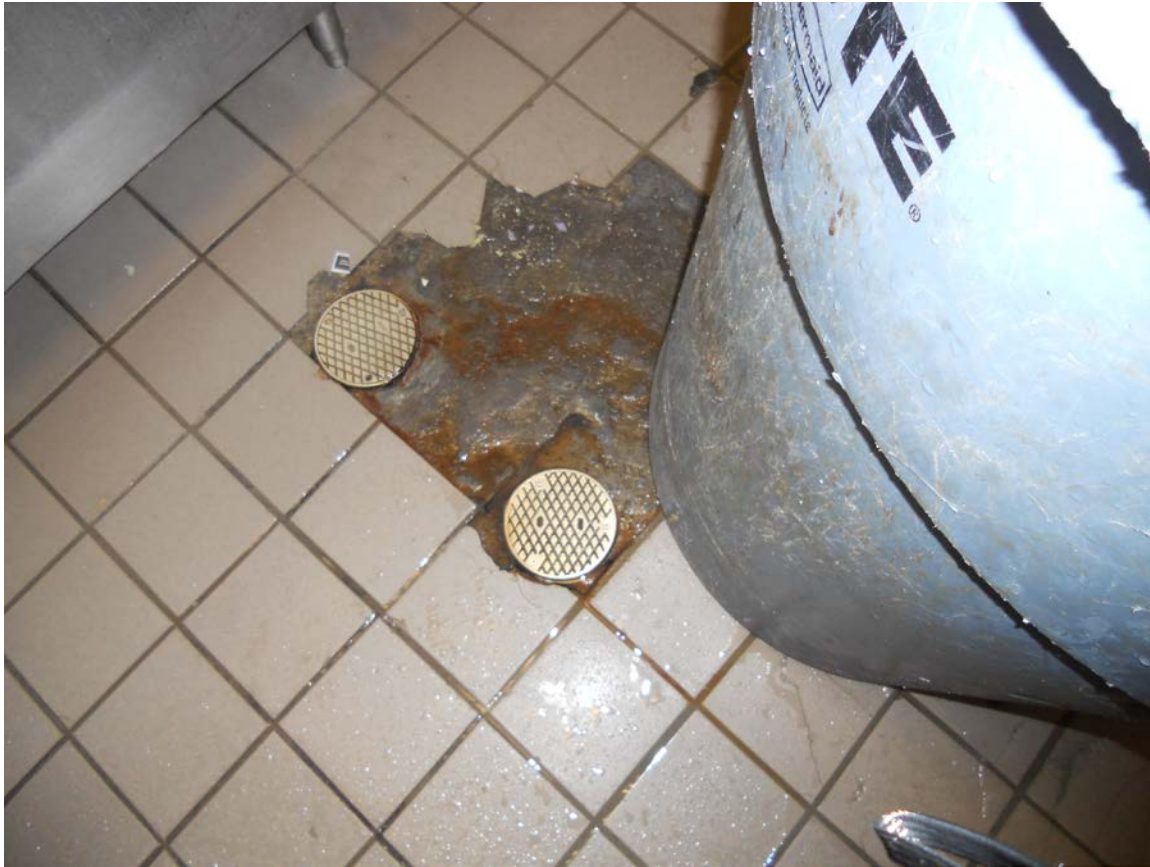
**Photo Exhibit: 50**

Kitchen: The tile floor (DSCN0568) in the dishwashing area. The leg of the dishwasher can be seen in the upper left corner of the picture. The condition of the floor surface allows for the potential contamination of foods, equipment, and supplies from dust and pathogens from pooled moisture. The floor's condition also hinders effective cleaning.

FDA Food Code Violation: 6-101.11

Materials for indoor floor, wall, and ceiling surfaces under conditions of normal use shall be smooth, durable, and easily cleanable for areas where food establishment operations are conducted.

FDA Food Code Violation: 6-501.11

Physical facilities shall be maintained in good repair.

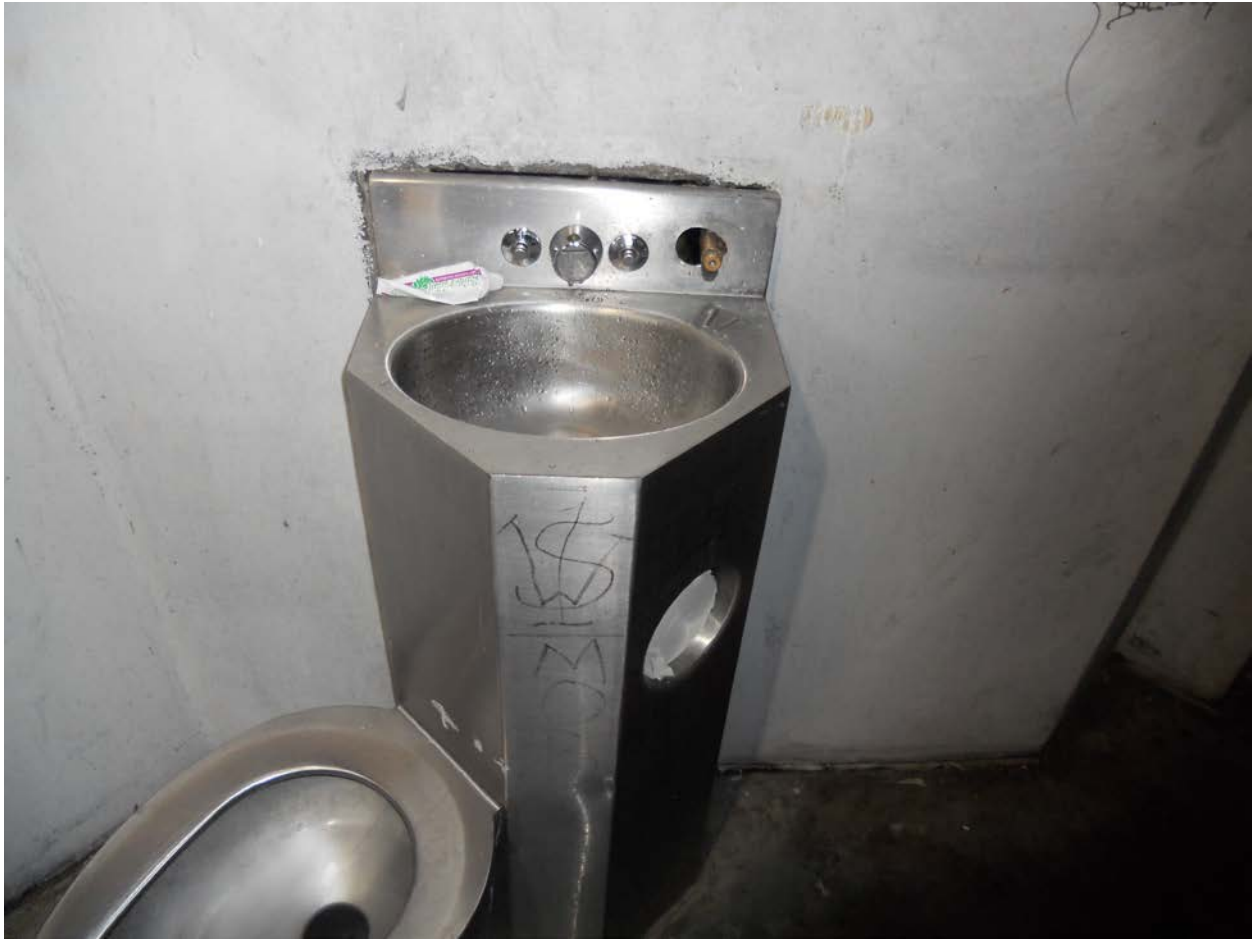
**Photo Exhibit: 51**

Housing Unit 6D: Combination toilet/lavatory unit in Cell 101 (DSCN1089). Holes such as this one at the flush mechanism and crevice created at the juncture with the wall allow the entry of disease carrying insects and rodents into the housing unit. Numerous flush mechanisms were found in this condition in various cells in units 5 and 6. The plumbing fixture and wall in this cell are not properly maintained as required by the APHA standard.

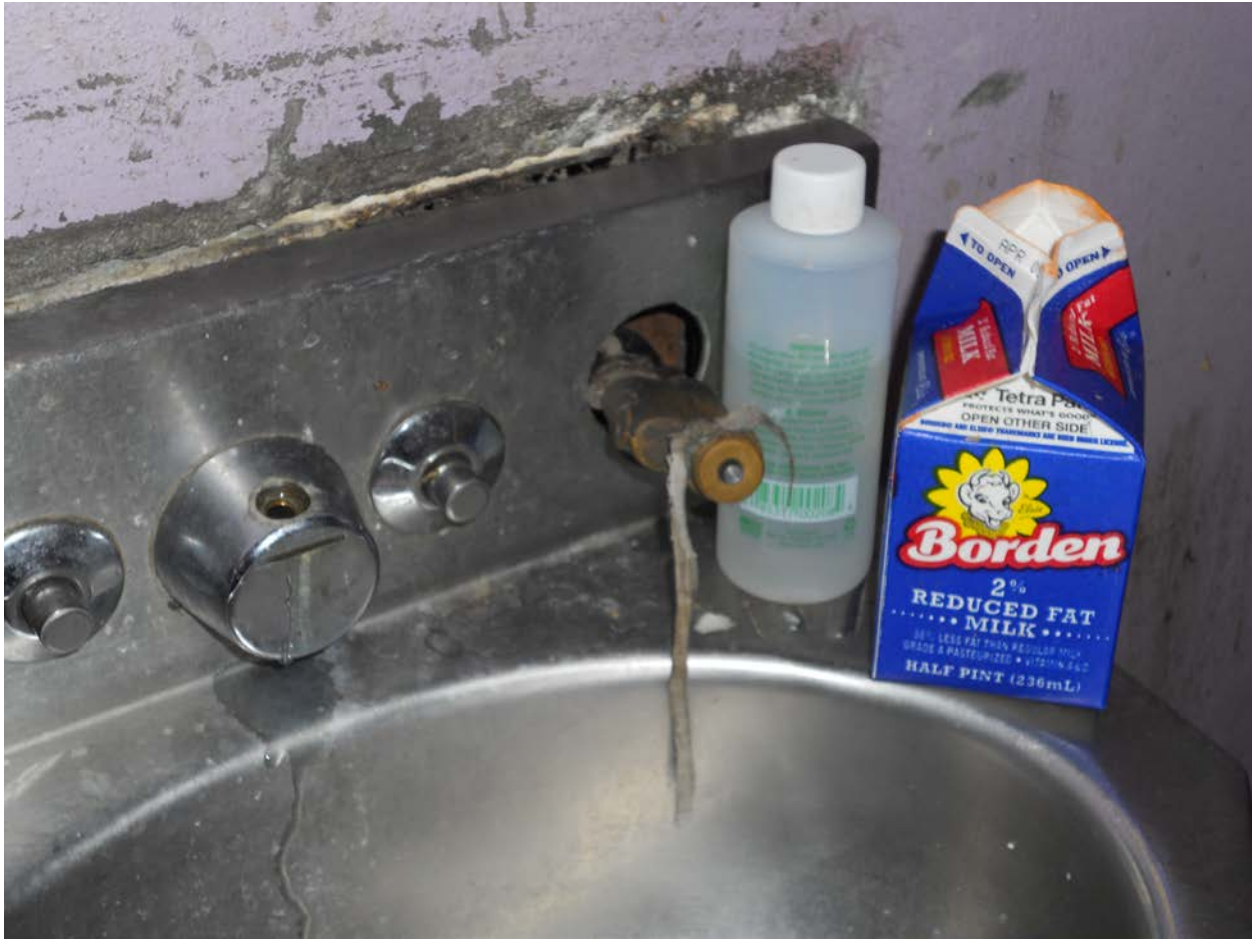
**Photo Exhibit: 52**

Housing Unit 5C: Flush mechanism on the combination toilet/sink unit in Cell 116 (DSCN0656). Openings such as the one at the control mechanism and at the wall juncture allow the entry of disease carrying insects and rodents into the housing unit. Additionally, the string tied to the flush mechanism is capable of supporting the growth of disease causing microorganisms. The plumbing fixture and wall in this cell are not properly maintained as required by the APHA standard.

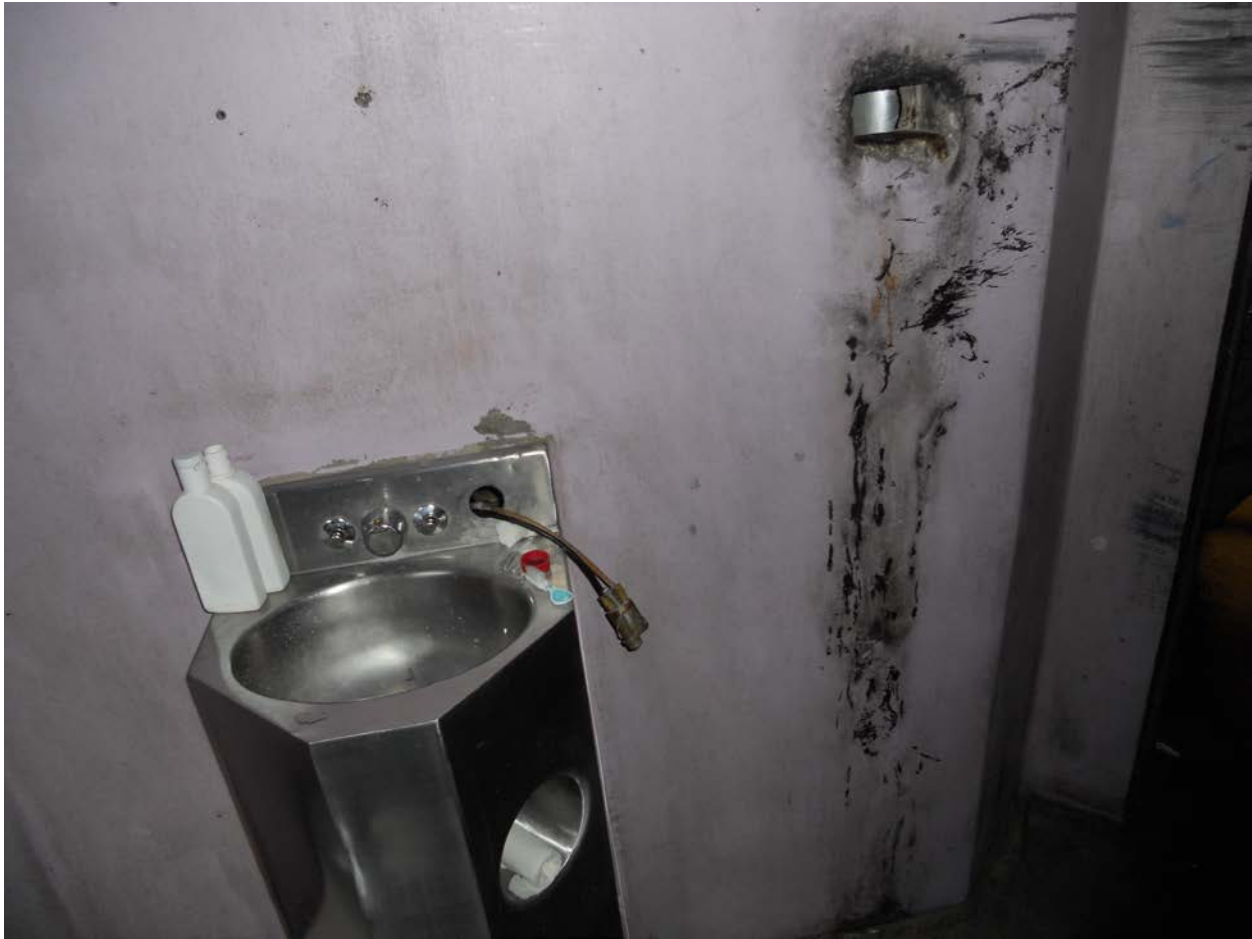
**Photo Exhibit: 53**

Housing Unit 5C: Combination toilet/lavatory unit in Cell 209 (DSCN0678). Openings such as the one created by the broken flush mechanism allow the entry of disease-carrying insects and rodents into the housing unit. Additionally, the level of soil build-up on the wall indicates that proper cleaning procedures are not being performed in the cell. The condition of this plumbing fixture and wall clearly indicate that the facility is not properly maintained, as required by the APHA standard.

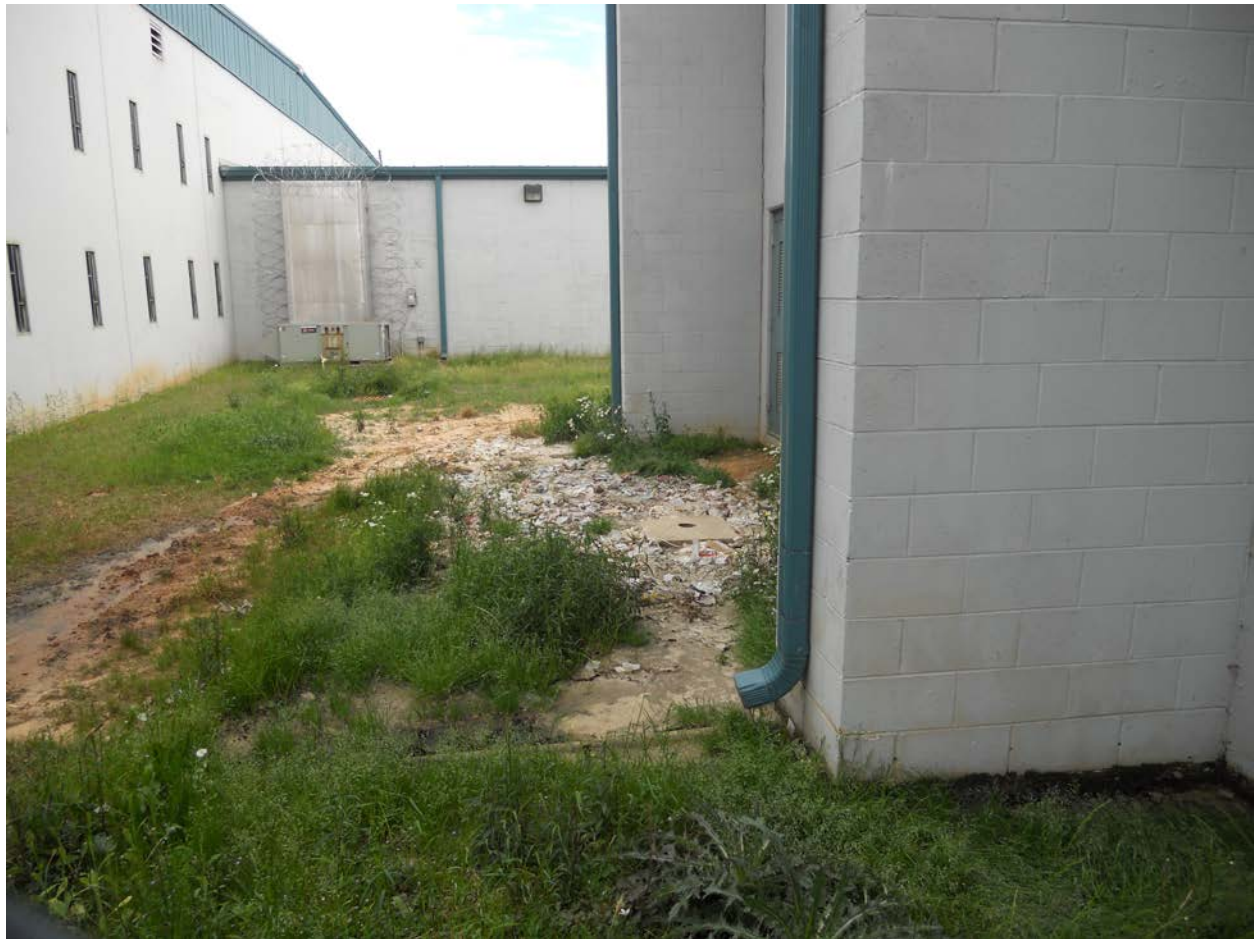
**Photo Exhibit: 54**

Exterior Yard: Debris field caused by backups of the sewage system (DSCN1347). Housing Unit 2C is the building on the left. The area is behind a locked fence and inaccessible to prisoners. Improper disposal of sewage has been linked to surface and groundwater pollution and the spread of disease.

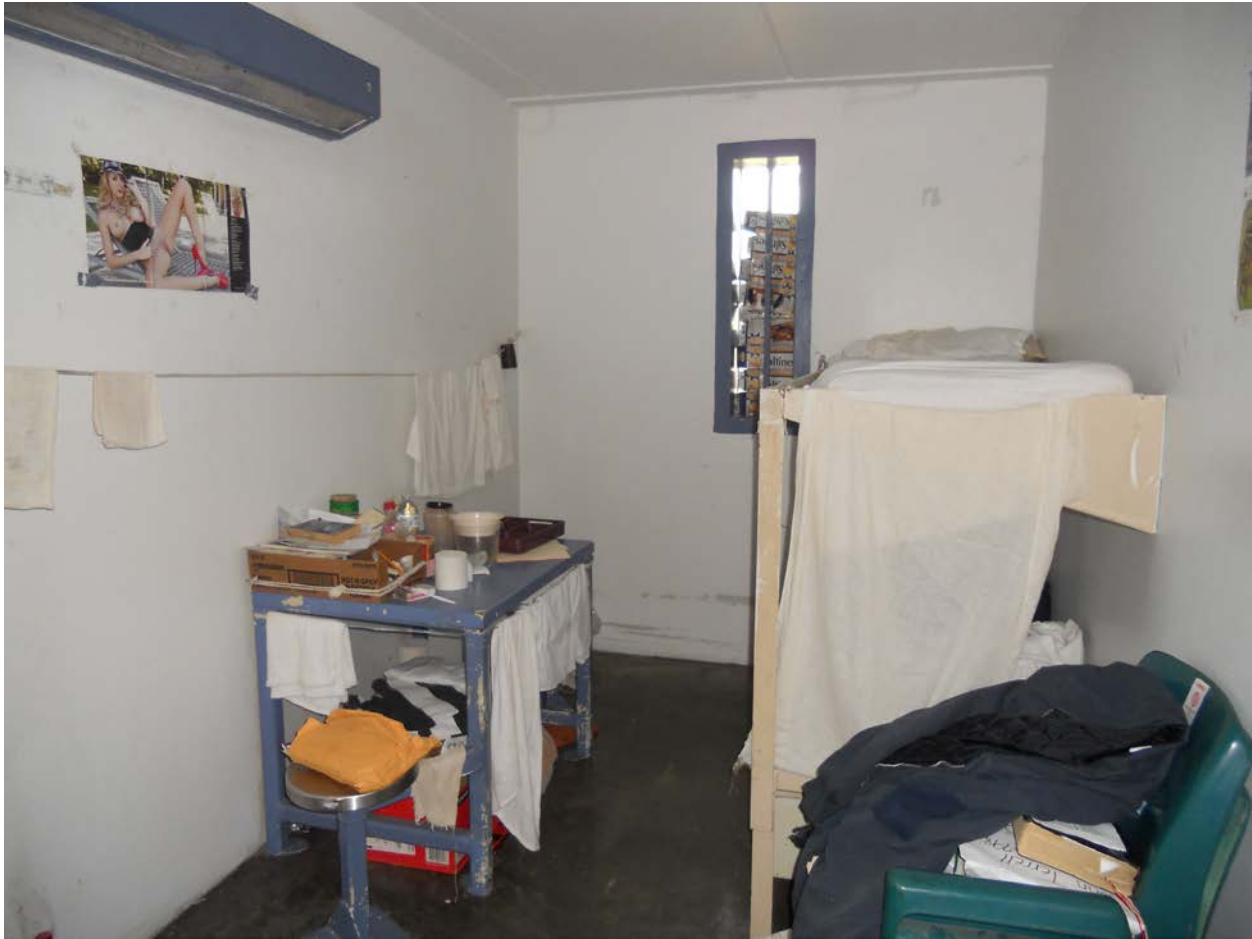
**Photo Exhibit: 55**

Housing Unit 4D: Interior picture of Cell 4D-103 (DSCN1260). A prisoner in a wheel chair indicated that he had been housed in this cell for approximately two months. The distance between the bunk and the desk, both bolted to the floor, is 26.75", and therefore less than the 30" by 48" bed transfer space required by the ADA's Accessible Cells in Correctional Facilities Design Guide. The inmate reported difficulty transferring from his wheelchair to the bed. This cell also has a regular combination toilet/lavatory unit instead of an accessible toilet with grab bars. Additionally, the light switch is on the light itself and can be seen as a lighter colored circle on the end of the light cover. The light switch was approximately 82" from the floor and cannot be controlled by an individual who can't reach it. However, the inmate reported that he preferred to stay in housing unit 4D for personal reasons of security and safety rather than moving to an accessible cell in a different unit. Cell 4D-115 is an accessible cell, but another prisoner in a wheelchair already occupied it. Additionally, the cluttered condition of the cell provides harborage for disease-carrying insects and rodents and the clothesline indicates that laundry is being washed in the housing unit rather than being sent to the laundry.
