Environmental Health Inspections  
East Mississippi Correctional Facility  
Meridian, Mississippi  
March 31, 2014 through April 3, 2014

June 13, 2014

Prepared by:  
**Diane Skipworth, R.D., L.D., R.S., CLLM**

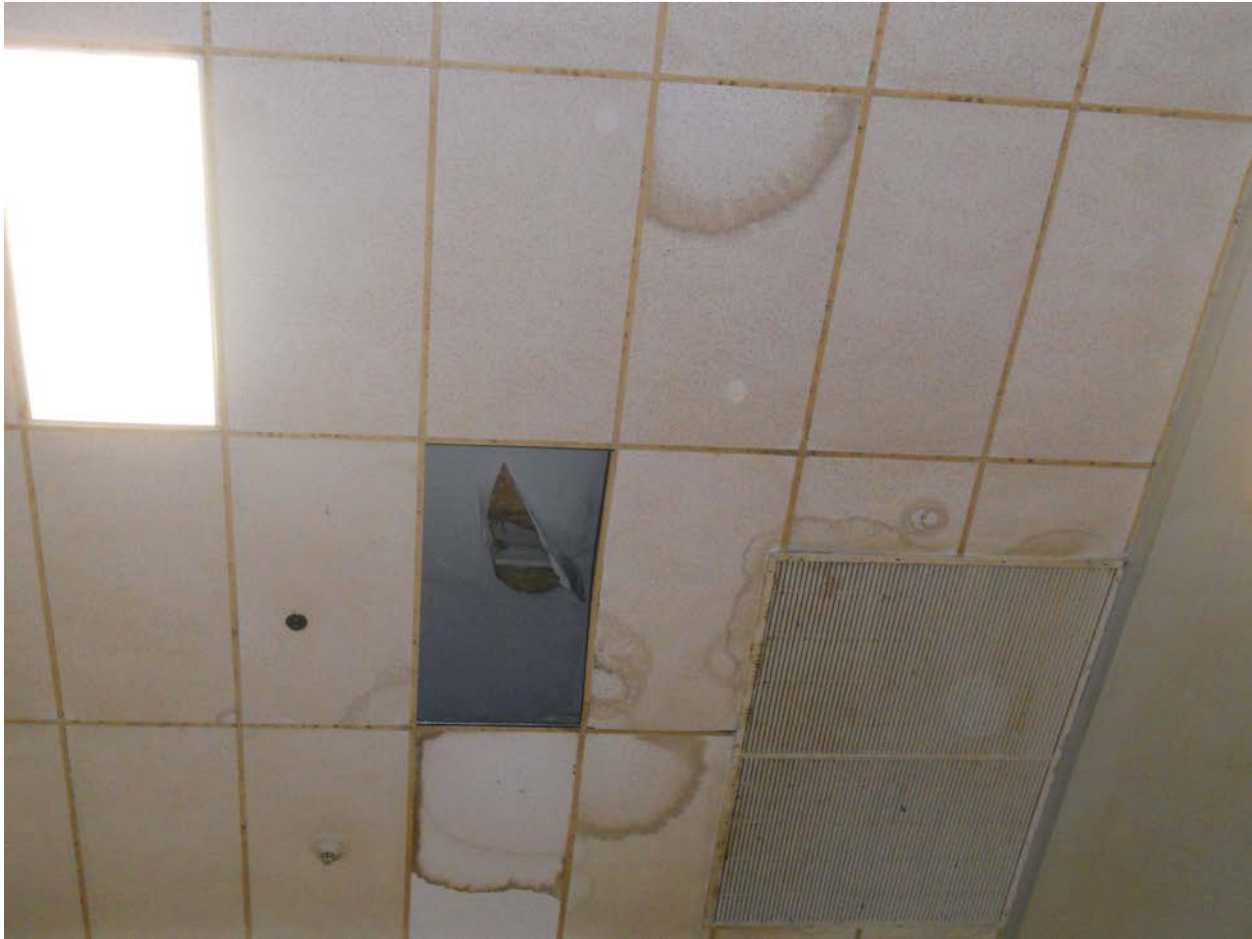
**Photo Exhibit: 56**

Housing Unit 4C: Condition of the dayroom ceiling (DSCN1267). The area is water damaged and the ceiling tile is peeling. This unsanitary condition exposes prisoners to the potential dangers of falling debris and illnesses related to bacterial and mold growths. The condition of this dayroom ceiling clearly indicates that the facility is not properly maintained, as required by the APHA standard.

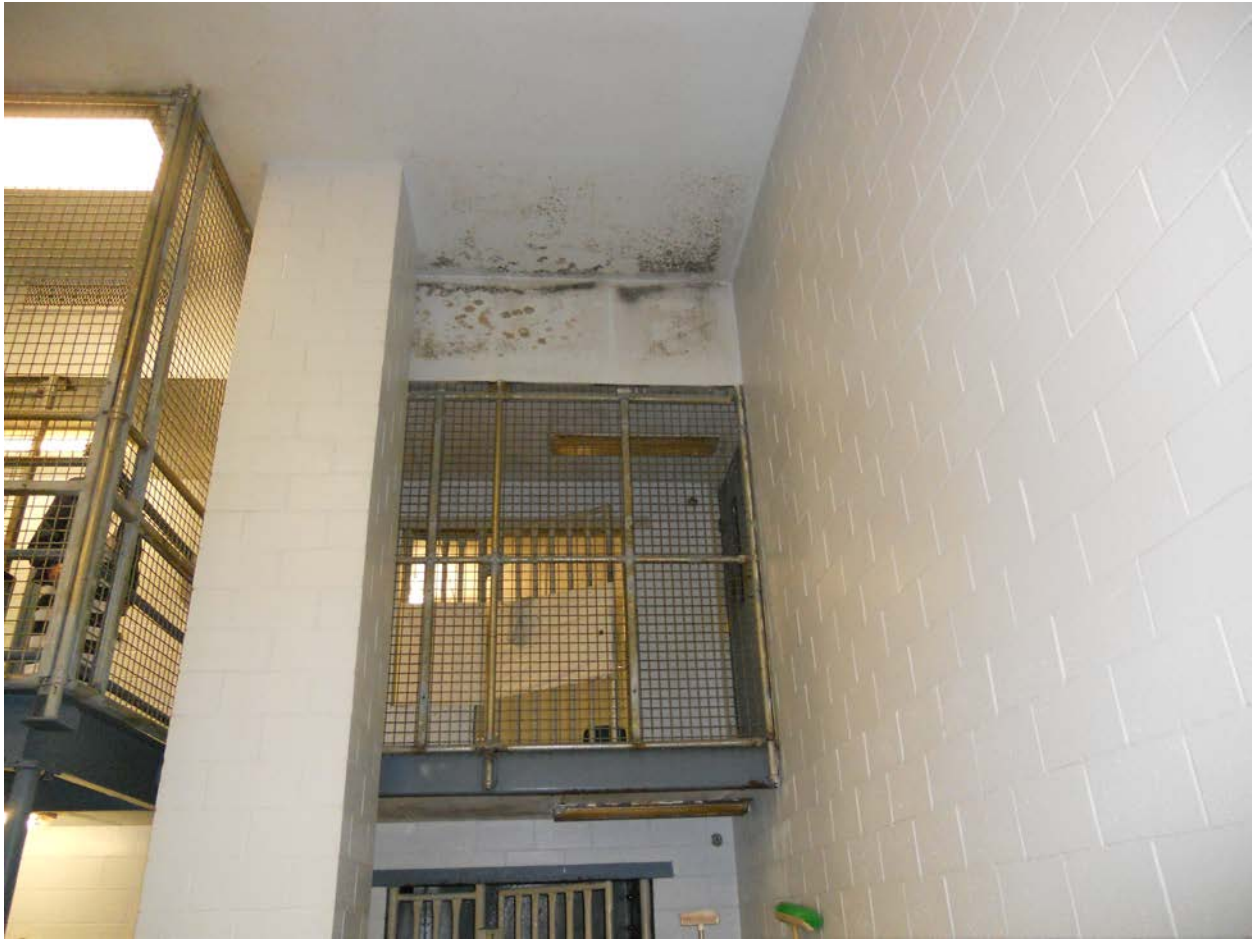
**Photo Exhibit: 57**

Housing Unit 1D: Upper and Lower Showers (DSCN1312). Visible mold growths can be seen on the ceiling. Additionally, nonfunctioning lights can be observed outside of both the upper and lower shower rooms. The lower shower room lights did not function at all and the measured illumination level was 0.03 to 0.15, well below the 20 foot candle minimum required for washrooms. The dim lighting levels increase the chance of accidental injury and hinder the performance of personal hygiene. Furthermore, the dimly lit areas pose a security problem, increasing the chance of violence.

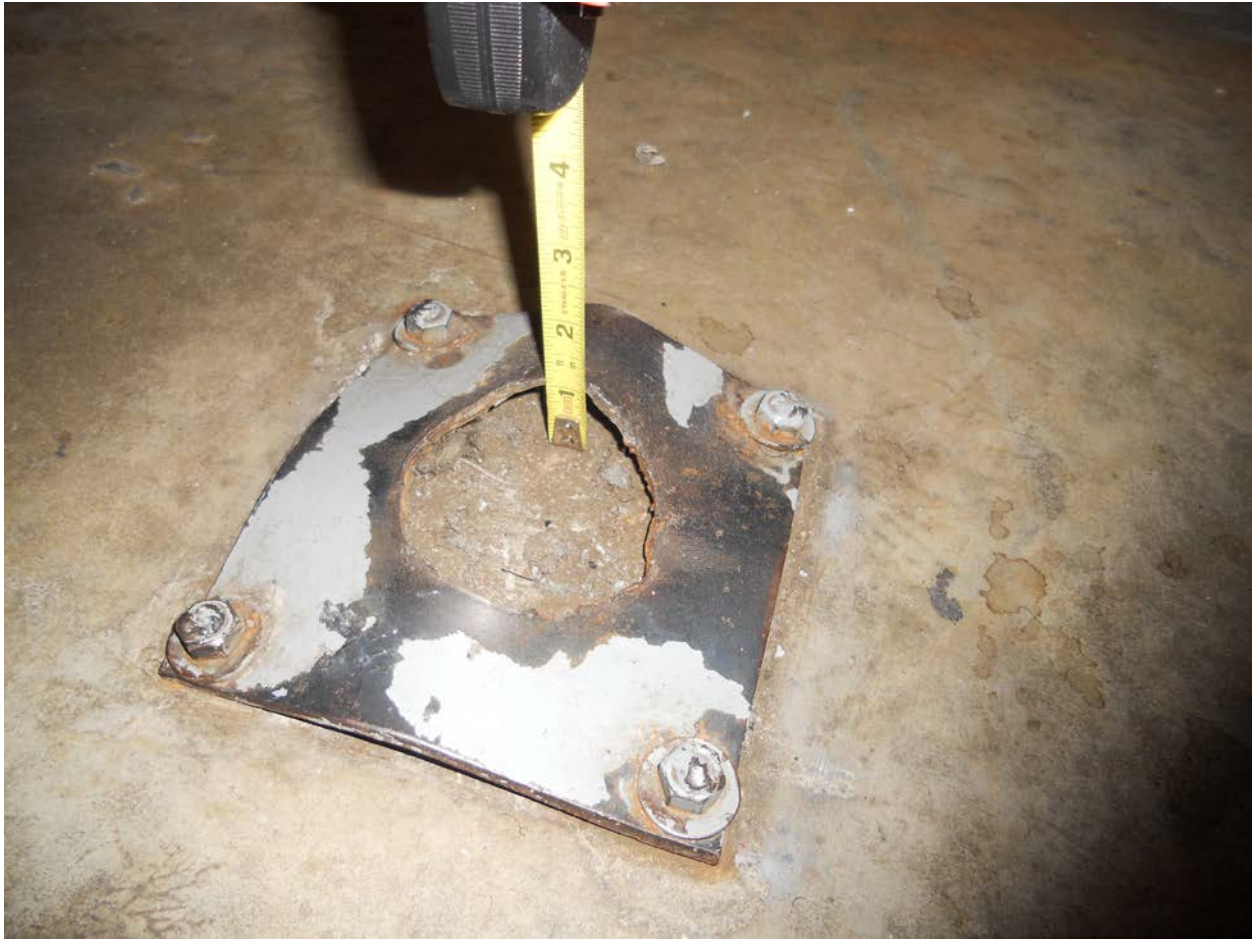
**Photo Exhibit: 58**

Housing Unit 6A: Rusty metal plate previously used to secure a stool the floor in Cell 104 (DSCN1147). The plate poses a serious trip-and-fall hazard. Additionally, this condition could cause serious foot injury, especially if a prisoner was walking barefoot in his cell. Furthermore, the lack of a stool leaves the prisoner with only the bunk for seating, making meal consumption and writing difficult.
